Access Compliance Report Public Rights-of-Way (Curb Ramps)

Main Street: CLEOME_ST **Cross Street:** TUBEROSE_ST **Location:** NW

ADA ID: RPAT211029131510 **Ramp Type:** Type 4 - Parallel **Initial Pass/Fail:** Fail **Overall Compliance:** No **Severity Score:** 2

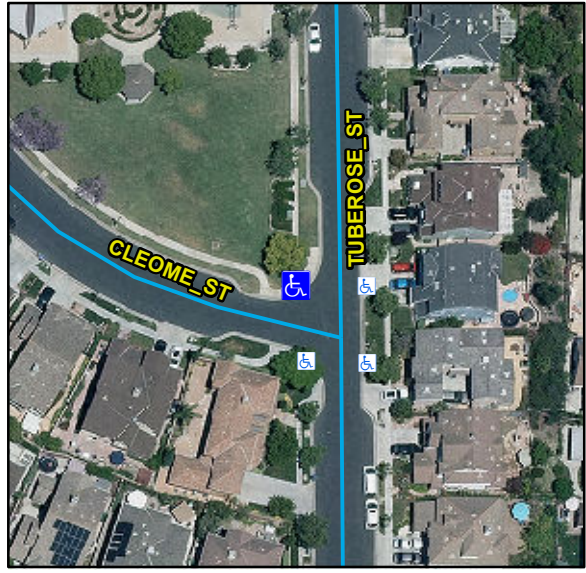
Compliance	Description	Data	Compliance	Description	Data
N/A	Ramp Length LT (in)	115	N/A	Ramp Length RT (in)	91
Yes	Ramp Width LT (in)	53	Yes	Ramp Width RT (in)	54
Yes	Ramp Run Slope LT (%)	5.1	Yes	Ramp Run Slope RT (%)	3.3
No	Ramp Cross Slope LT (%)	3	No	Ramp Cross Slope RT (%)	2.8
N/A	Landing Present	N/A	N/A	DWS Provided	N/A
N/A	Landing Length (in)	N/A	N/A	DWS Contrast	N/A
N/A	Landing Width (in)	N/A	N/A	DWS Length (in)	N/A
N/A	Landing Run Slope (%)	N/A	N/A	DWS Full Width	N/A
N/A	Landing Cross Slope (%)	N/A		DWS Offset Type	N/A
N/A	Landing Movement Obstructed?	N/A	N/A	DWS Offset Left (in)	N/A
	Landing Movement Type	N/A	N/A	DWS Offset Right (in)	N/A
N/A	Landing Shared	N/A			
N/A	Clear Space	Yes			
N/A	Clear Space To Crosswalk (in)	N/A			
N/A	Marked Crosswalk 1	No	N/A	Marked Crosswalk 2	No
	Crossing 1 Direction	S		Crossing 2 Direction	E
N/A	Marked Crosswalk 1 Width (in)	N/A	N/A	Marked Crosswalk 2 Width (in)	N/A

N/A	Ramp Inside Crosswalk 1	N/A	N/A	Ramp Inside Crosswalk 2	N/A
	Crossing 1 Slope (%)	2.9		Crossing 2 Slope (%)	1.1
	Crossing 1 Cross Slope (%)	0.3		Crossing 2 Cross Slope (%)	1
N/A	Gutter Ponding	N/A	N/A	Curb Slope	9.4
Yes	Gutter Lip Height (in)	0		Road Run Slope (%)	0.2
N/A	Gutter Run Slope (%)	N/A		Road Cross Slope (%)	1.3
N/A	Gutter Cross Slope (%)	N/A	No	Perpendicular Joint Present	No
Yes	Overall Surface Condition	Acceptable		Spandrel Present?	No
	Cross Gutter Present?	No		Replace Spandrel?	N/A
	Replace Cross Gutter?	N/A

Possible Solutions:
Remove & Replace Curb Ramp With Two New Directional Ramps or Equivalent.

OC Std/PROW:
R204.3, R304.5.3, STD 1115
