# Access Compliance Report Public Rights-of-Way (Curb Ramps)

Main Street: BARBERRY\_ST Cross Street: TUBEROSE\_ST Location: SE

ADA ID: RPAT211029131927 Ramp Type: Type 4 - Parallel Initial Pass/Fail: Fail Overall Compliance: No Severity Score: 2

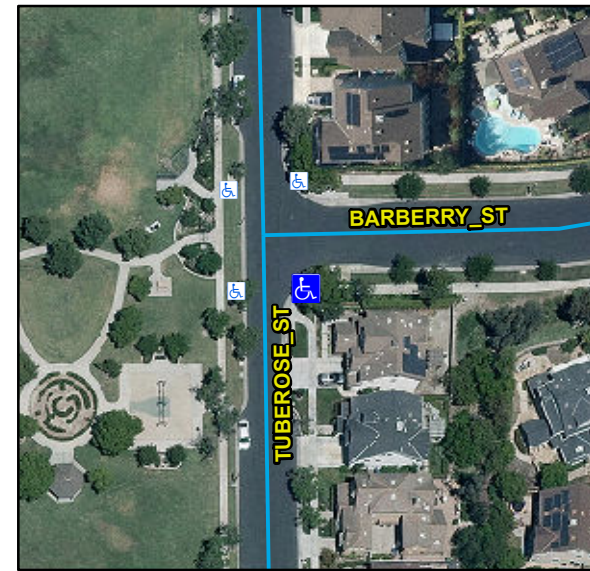
| Compliance | Description | Data | Compliance | Description | Data |
|---|---|---|---|---|---|
| Yes | Ramp Cross Slope LT (%) | 1.5 | No | Ramp Cross Slope RT (%) | 2.7 |
| N/A | Gutter Cross Slope (%) | N/A | No | Perpendicular Joint Present | No |

**Remove & Replace Curb Ramp With Two New Directional Ramps or Equivalent.**

**R204.3, R304.5.3, STD 1115**

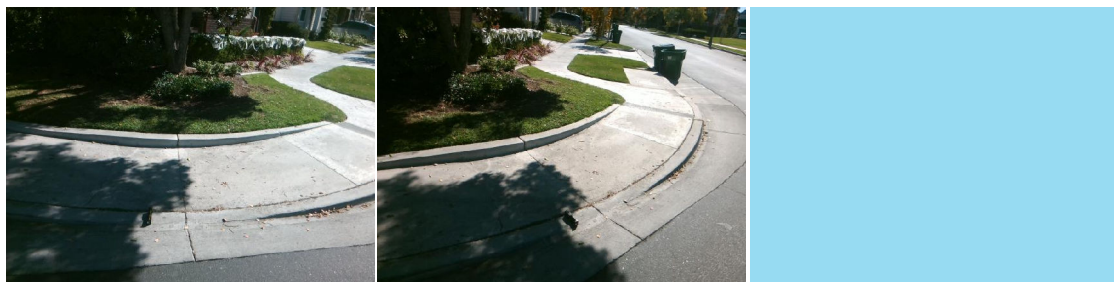
| Compliance | Description | Data | Compliance | Description | Data |
|---|---|---|---|---|---|
| N/A | Ramp Length LT (in) | 105 | N/A | Ramp Length RT (in) | 47 |
| Yes | Ramp Width LT (in) | 53 | Yes | Ramp Width RT (in) | 53 |
| Yes | Ramp Run Slope LT (%) | 5.6 | Yes | Ramp Run Slope RT (%) | 7.3 |
