# Access Compliance Report Public Rights-of-Way (Curb Ramps)

Main Street: TUBEROSE\_ST Cross Street: BARBERRY\_ST Location: NE

ADA ID: RPAT211029132223 Ramp Type: Type 4 - Parallel Initial Pass/Fail: Fail Overall Compliance: No Severity Score: 16

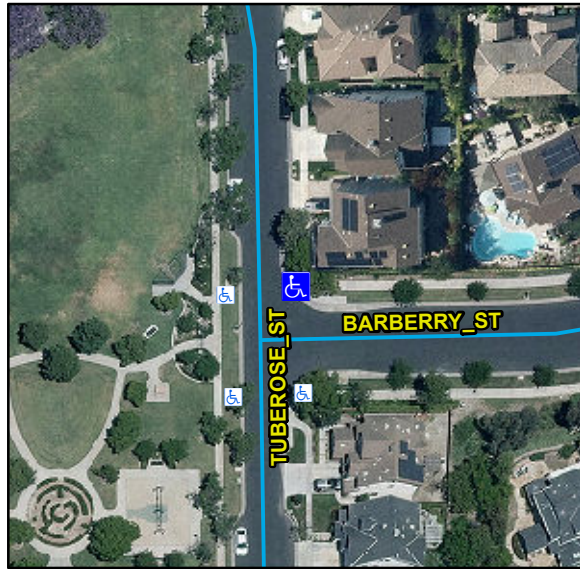
| Compliance | Description | Data | Compliance | Description | Data |
|---|---|---|---|---|---|
| Yes | Ramp Run Slope LT (%) | 1.3 | No | Ramp Run Slope RT (%) | 10.4 |
| No | Ramp Cross Slope LT (%) | 5 | Yes | Ramp Cross Slope RT (%) | 1.3 |

**Remove & Replace Curb Ramp With Two New Directional Ramps or Equivalent.**

**R204.3, R304.5.3, R304.3.2, STD 1115**
