# Access Compliance Report Public Rights-of-Way (Curb Ramps)

Main Street: CLEOME\_ST Cross Street: MERRIWEATHER\_PL Location: SW

ADA ID: RPAT211029132753 Ramp Type: Type 4 - Parallel Initial Pass/Fail: Fail Overall Compliance: No Severity Score: 16

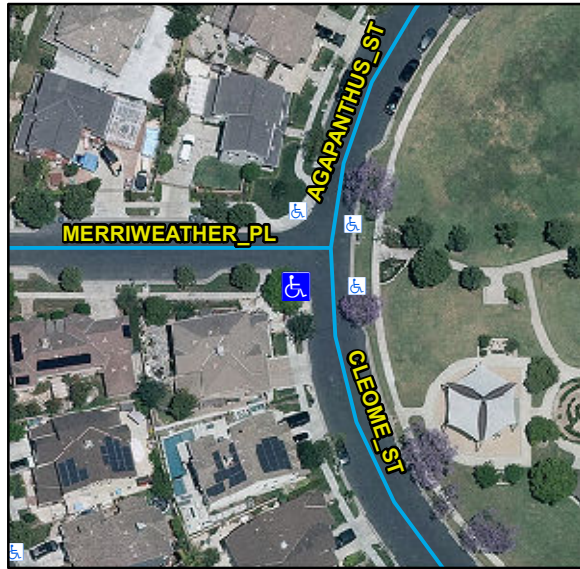
| Compliance | Description | Data | Compliance | Description | Data |
|---|---|---|---|---|---|
| No | Ramp Run Slope LT (%) | 8.4 | Yes | Ramp Run Slope RT (%) | 2.5 |
| No | Ramp Cross Slope LT (%) | 4.2 | Yes | Ramp Cross Slope RT (%) | 0.7 |

Remove & Replace Curb Ramp With Two New Directional Ramps or Equivalent.

R204.3, R304.3.2, R304.5.3, STD 1115
