# Access Compliance Report Public Rights-of-Way (Curb Ramps)

Main Street: MERRIWEATHER\_PL Cross Street: AGAPANTHUS\_ST Location: NW

ADA ID: RPAT211029133027 Ramp Type: Type 4 - Parallel Initial Pass/Fail: Pass Overall Compliance: No Severity Score: 19

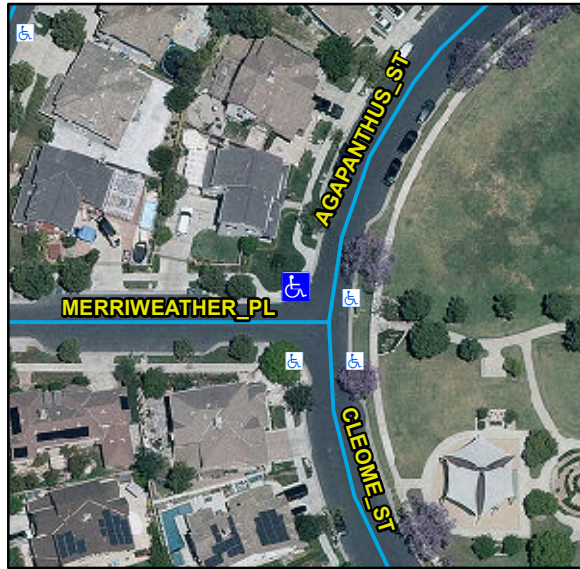
| Compliance | Description | Data | Compliance | Description | Data |
|---|---|---|---|---|---|
| N/A | Landing Present | Yes | No | DWS Provided | No |
| No | Landing Width (in) | 42 | N/A | DWS Length (in) | N/A |
| Yes | Gutter Ponding | No | No | Curb Slope | 12.8 |
| No | Gutter Run Slope (%) | 8.7 | | Road Cross Slope (%) | 1.9 |

Remove & Replace Curb Ramp With Two New Directional Ramps or Equivalent. Remove & Replace Gutter.
