# Access Compliance Report Public Rights-of-Way (Curb Ramps)

Main Street: MERRIWEATHER\_PL Cross Street: CELESTINE\_CIR Location: SE

ADA ID: RPAT211029133542 Ramp Type: Type 4 - Parallel Initial Pass/Fail: Fail Overall Compliance: No Severity Score: 2

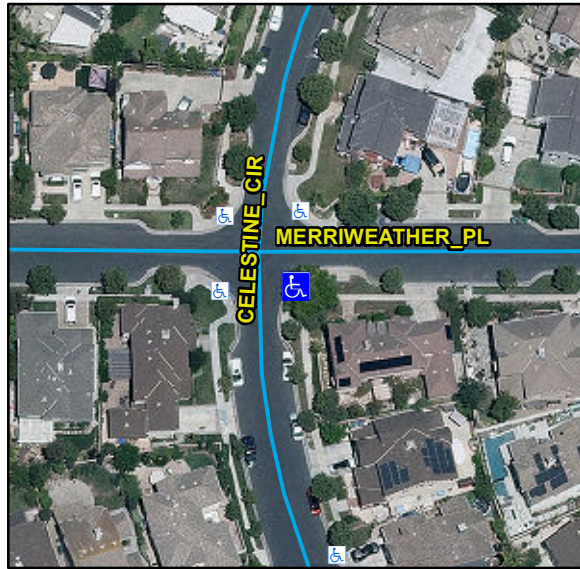
| Compliance | Description | Data | Compliance | Description | Data |
|---|---|---|---|---|---|
| No | Ramp Cross Slope LT (%) | 2.4 | Yes | Ramp Cross Slope RT (%) | 1.8 |

**Remove & Replace Curb Ramp With Two New Directional Ramps or Equivalent.**

**R204.3, R304.5.3, STD 1115**
