# Access Compliance Report Public Rights-of-Way (Curb Ramps)

Main Street: CELESTINE\_CIR Cross Street: MERRIWEATHER\_PL Location: NE

ADA ID: RPAT211029133839 Ramp Type: Type 4 - Parallel Initial Pass/Fail: Pass Overall Compliance: No Severity Score: 20

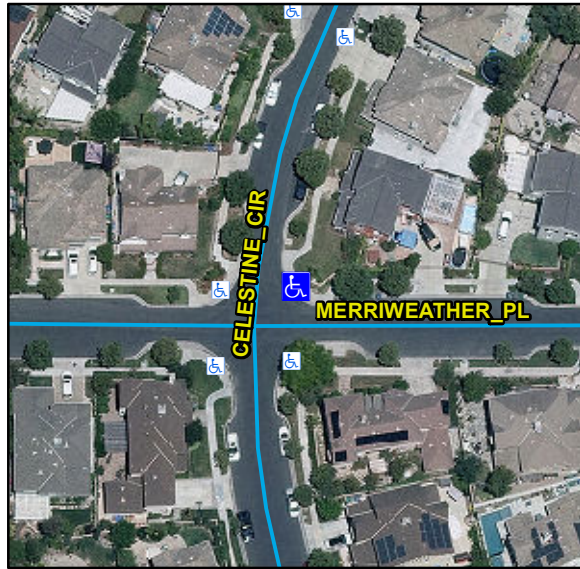
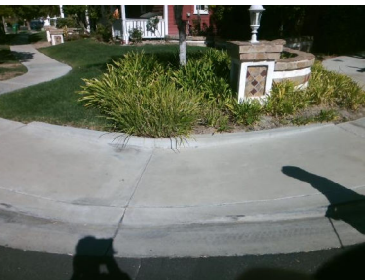
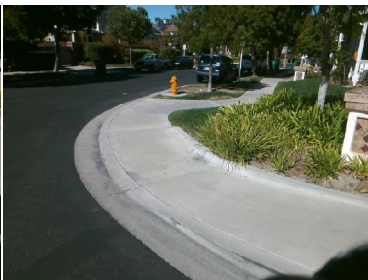
| Compliance | Description | Data | Compliance | Description | Data |
|---|---|---|---|---|---|
| N/A | Landing Present | Yes | No | DWS Provided | No |
| No | Landing Width (in) | 42 | N/A | DWS Length (in) | N/A |
| No | Landing Cross Slope (%) | 2.5 | | DWS Offset Type | N/A |
| Yes | Gutter Ponding | No | No | Curb Slope | 10.1 |
| No | Gutter Run Slope (%) | 7.4 | | Road Cross Slope (%) | 3.3 |
| Yes | Gutter Cross Slope (%) | 2 | No | Perpendicular Joint Present | No |

Remove & Replace Curb Ramp With Two New Directional Ramps or Equivalent. Remove & Replace Gutter.

Total Cost: \$ 4252
