# Access Compliance Report Public Rights-of-Way (Curb Ramps)

Main Street: SKLAR\_ST Cross Street: RANUNCULUS\_ST Location: E

ADA ID: RPAT211029151334 Ramp Type: Type 1 - Perpendicular Diagonal Initial Pass/Fail: Pass Overall Compliance: No Severity Score: 25

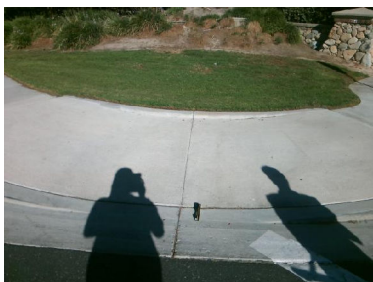
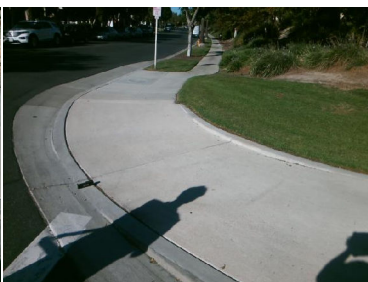
| Compliance | Description | Data | Compliance | Description | Data |
|---|---|---|---|---|---|
| No | Landing Width (in) | N/A | N/A | Flare Slope RT (%) | 4.5 |
| No | Landing Run Slope (%) | N/A | N/A | Flare Traversable RT | No |
| No | Landing Cross Slope (%) | N/A | No | DWS Provided | No |
| Yes | Gutter Ponding | No | No | Curb Slope | 7.4 |
| No | Gutter Run Slope (%) | 8.5 | | Road Cross Slope (%) | 3.9 |

Remove & Replace Curb Ramp With Two New Directional Ramps or Equivalent. Remove & Replace Gutter.
