# Access Compliance Report Public Rights-of-Way (Curb Ramps)

| Main Street: RANUNCULUS_ST | | Cross Street: SKLAR_ST | | Location: | SE |
| ADA ID: RPAT211029151722 | Ramp Type: Type 4 - Parallel | Initial Pass/Fail: Fail | Overall Compliance: No | Severity Score: | 16 |

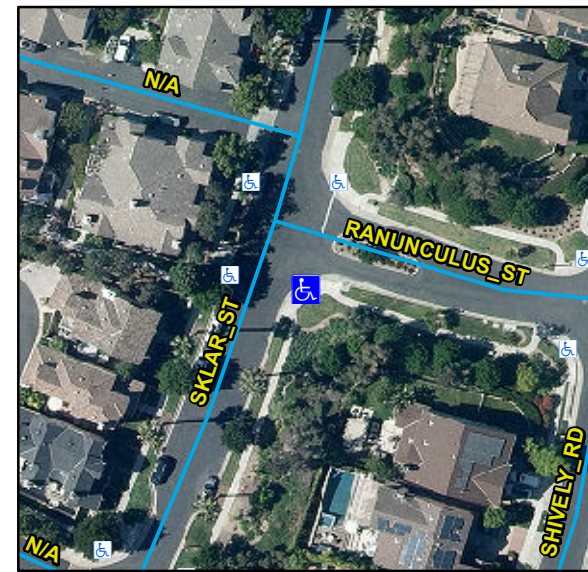
| Compliance | Description | Data | Compliance | Description | Data |
|---|---|---|---|---|---|
| No | Ramp Run Slope LT (%) | 11.3 | Yes | Ramp Run Slope RT (%) | 2.5 |
| No | Ramp Cross Slope LT (%) | 2.7 | No | Ramp Cross Slope RT (%) | 2.7 |

**Remove & Replace Curb Ramp With Two New Directional Ramps or Equivalent.**

**R204.3, R304.3.2, R304.5.3, STD 1115**
