# Access Compliance Report Public Rights-of-Way (Curb Ramps)

| Main Street: BLACK_CHERRY_ST | | Cross Street: TERRASTAR_LN | | Location: | NE |
| ADA ID: RPAT211101093638 | Ramp Type: Type 4 - Parallel | Initial Pass/Fail: Pass | Overall Compliance: No | Severity Score: | 12 |

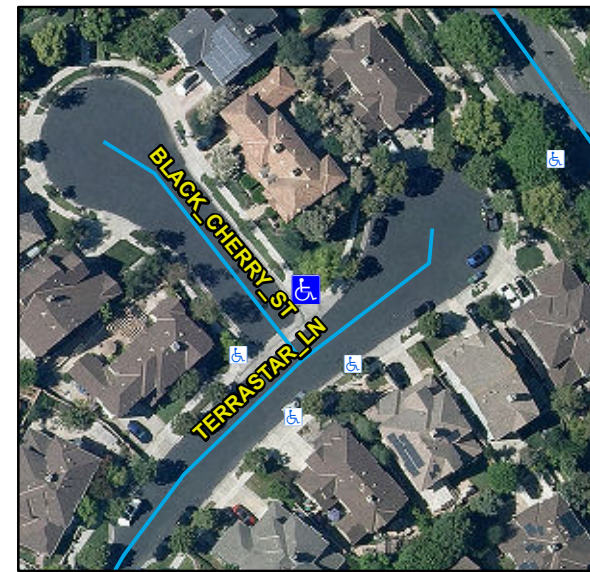
| Compliance | Description | Data | Compliance | Description | Data |
|---|---|---|---|---|---|
| No | Ramp Cross Slope LT (%) | 4.2 | Yes | Ramp Cross Slope RT (%) | 1 |
| N/A | Landing Present | Yes | No | DWS Provided | No |
| No | Landing Run Slope (%) | 3.8 | N/A | DWS Full Width | N/A |
| No | Landing Cross Slope (%) | 2.6 | | DWS Offset Type | N/A |
| No | Gutter Cross Slope (%) | 3 | No | Perpendicular Joint Present | No |

**Remove & Replace Curb Ramp With Two New Directional Ramps or Equivalent. Remove & Replace Gutter.**

**R204.3, R304.5.3, R304.2.2-Perp, R304.3.2-Para, R305, STD 1115**
