# Access Compliance Report Public Rights-of-Way (Curb Ramps)

Main Street: TERRASTAR\_LN Cross Street: BLACK\_CHERRY\_ST Location: NW

ADA ID: RPAT211101094055 Ramp Type: Type 4 - Parallel Initial Pass/Fail: Fail Overall Compliance: No Severity Score: 16

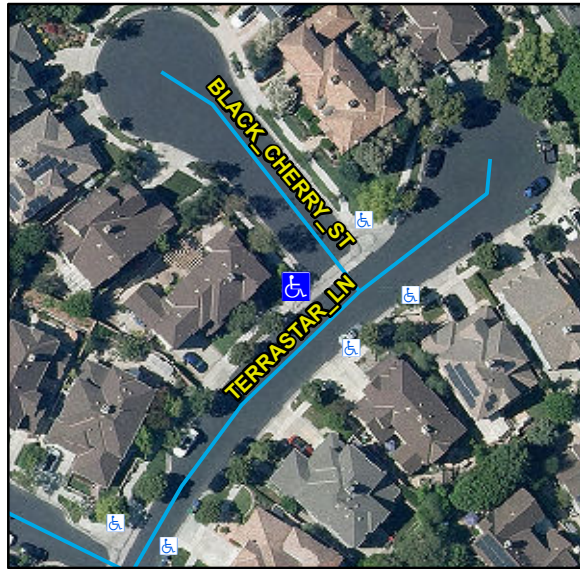
| Compliance | Description | Data | Compliance | Description | Data |
|---|---|---|---|---|---|
| Yes | Ramp Run Slope LT (%) | 3.9 | No | Ramp Run Slope RT (%) | 11.5 |
| No | Ramp Cross Slope LT (%) | 3.6 | No | Ramp Cross Slope RT (%) | 2.7 |

Remove & Replace Curb Ramp With Two New Directional Ramps or Equivalent.
