# Access Compliance Report Public Rights-of-Way (Curb Ramps)

Main Street: **BROOKWOOD\_ST** Cross Street: **TERRASTAR\_LN** Location: **N**

ADA ID: **RPAT211101094415** Ramp Type: **Type 4 - Parallel** Initial Pass/Fail: **Fail** Overall Compliance: **No** Severity Score: **2**

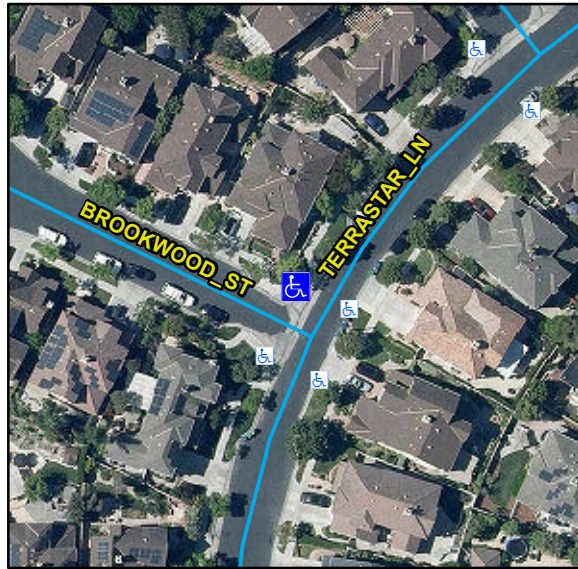
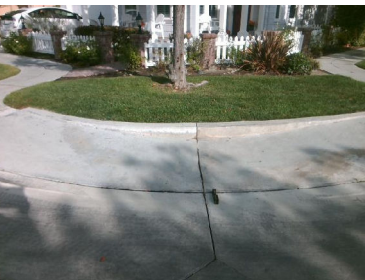
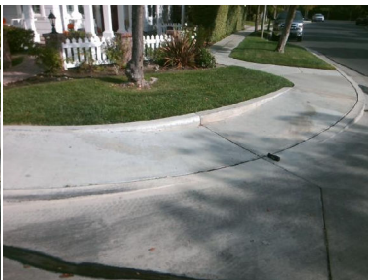
| Compliance | Description | Data | Compliance | Description | Data |
|---|---|---|---|---|---|
| <b>Yes</b> | Ramp Cross Slope LT (%) | <b>1.8</b> | <b>No</b> | Ramp Cross Slope RT (%) | <b>3.3</b> |
| <b>N/A</b> | Gutter Cross Slope (%) | <b>N/A</b> | <b>No</b> | Perpendicular Joint Present | <b>No</b> |

**Remove & Replace Curb Ramp With Two New Directional Ramps or Equivalent.**
