# Access Compliance Report Public Rights-of-Way (Curb Ramps)

| Main Street: TERRASTAR_LN | | Cross Street: BROOKWOOD_ST | | Location: | W |
| ADA ID: RPAT211101094727 | Ramp Type: Type 4 - Parallel | Initial Pass/Fail: Pass | Overall Compliance: No | Severity Score: | 10 |

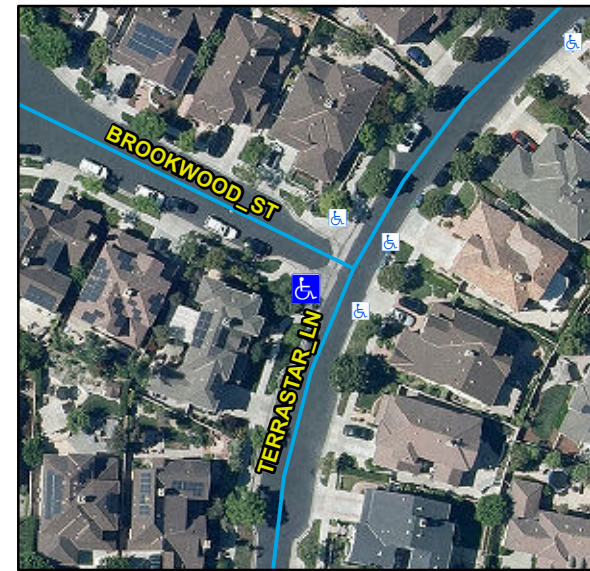
| Compliance | Description | Data | Compliance | Description | Data |
|---|---|---|---|---|---|
| N/A | Landing Present | Yes | No | DWS Provided | No |
| Yes | Gutter Cross Slope (%) | 2.8 | No | Perpendicular Joint Present | No |

Possible Solutions:

**Remove & Replace Curb Ramp With Two New Directional Ramps or Equivalent.**

OC Std/PROW:

**R204.3, R305, STD 1115**

Total Cost: \$ 4000
