# Access Compliance Report Public Rights-of-Way (Curb Ramps)

| Main Street: TETHER_MOON_LN | | Cross Street: TERRASTAR_LN | | Location: | NW |
| ADA ID: RPAT211101095223 | Ramp Type: Type 4 - Parallel | Initial Pass/Fail: Fail | Overall Compliance: No | Severity Score: | 16 |

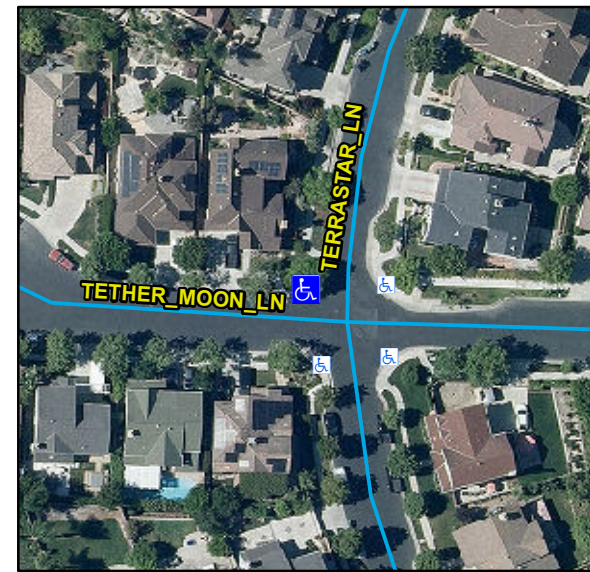
| Compliance | Description | Data | Compliance | Description | Data |
|---|---|---|---|---|---|
| Yes | Ramp Run Slope LT (%) | 1.1 | No | Ramp Run Slope RT (%) | 8.4 |
| Yes | Ramp Cross Slope LT (%) | 0.3 | No | Ramp Cross Slope RT (%) | 2.9 |

**Remove & Replace Curb Ramp With Two New Directional Ramps or Equivalent.**

**R204.3, R304.3.2, R304.5.3, STD 1115**

Total Cost: \$ 4000
