# Access Compliance Report Public Rights-of-Way (Curb Ramps)

Main Street: TERRASTAR\_LN Cross Street: TETHER\_MOON\_LN Location: NE

ADA ID: RPAT211101095446 Ramp Type: Type 4 - Parallel Initial Pass/Fail: Fail Overall Compliance: No Severity Score: 2

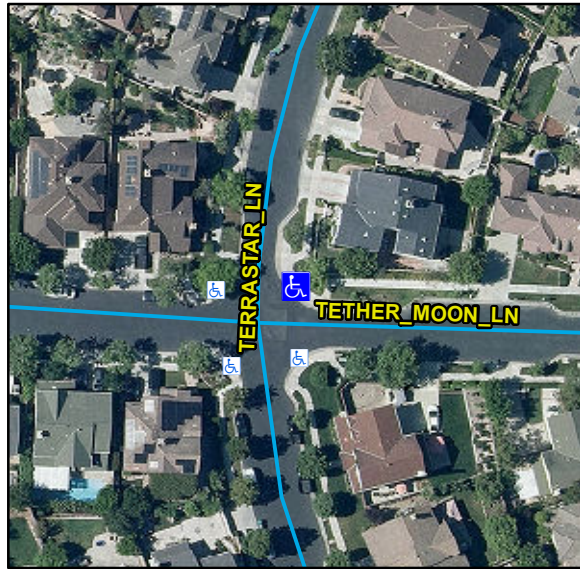
| Compliance | Description | Data | Compliance | Description | Data |
|---|---|---|---|---|---|
| No | Ramp Cross Slope LT (%) | 4.1 | No | Ramp Cross Slope RT (%) | 2.7 |

**Remove & Replace Curb Ramp With Two New Directional Ramps or Equivalent.**

**R304.2.2, R204.3, R304.5.3, STD 1115**
