# Access Compliance Report Public Rights-of-Way (Curb Ramps)

Main Street: TETHER\_MOON\_LN Cross Street: TERRASTAR\_LN Location: SE

ADA ID: RPAT211101095718 Ramp Type: Type 4 - Parallel Initial Pass/Fail: Pass Overall Compliance: No Severity Score: 6

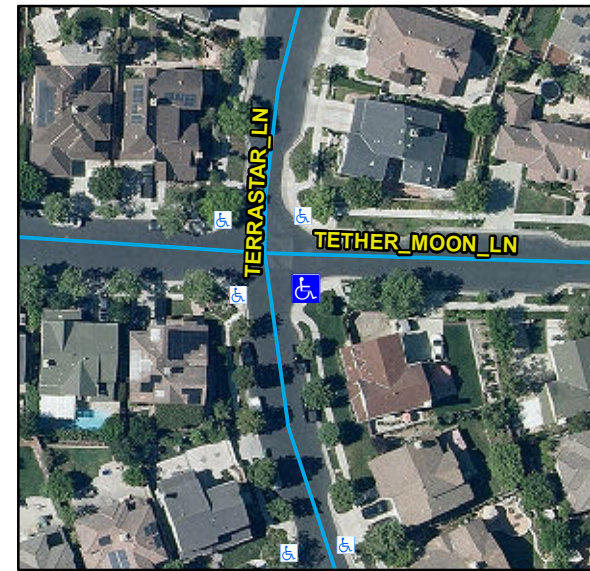
| Compliance | Description | Data | Compliance | Description | Data |
|---|---|---|---|---|---|
| No | Landing Run Slope (%) | 3.1 | Yes | DWS Full Width | Yes |
| No | Landing Cross Slope (%) | 2.2 | | DWS Offset Type | Single |
| No | Gutter Run Slope (%) | 11.7 | | Road Cross Slope (%) | 2.2 |

Remove & Replace Curb Ramp With Two New Directional Ramps or Equivalent. Remove & Replace Gutter.

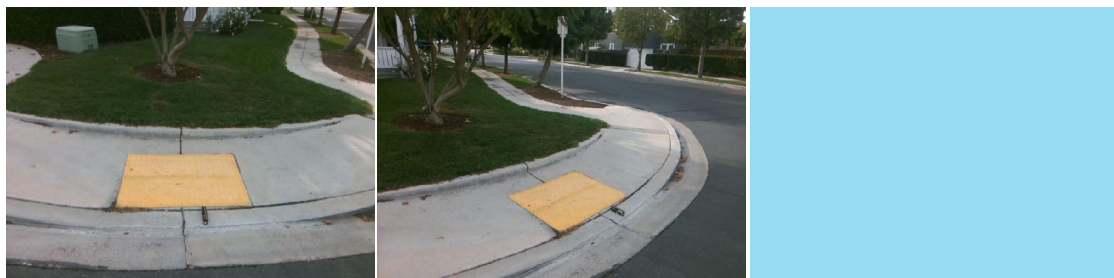
## Obstruction and Utility Measurement/Component Compliance

| Compliance | Description | Data | Compliance | Description | Data |
|---|---|---|---|---|---|
| Yes | Obstructions Present? | No | N/A | Utilities Present? | No |
