# Access Compliance Report Public Rights-of-Way (Curb Ramps)

Main Street: TERRASTAR\_LN Cross Street: TETHER\_MOON\_LN Location: SW

ADA ID: RPAT211101100105 Ramp Type: Type 4 - Parallel Initial Pass/Fail: Pass Overall Compliance: No Severity Score: 6

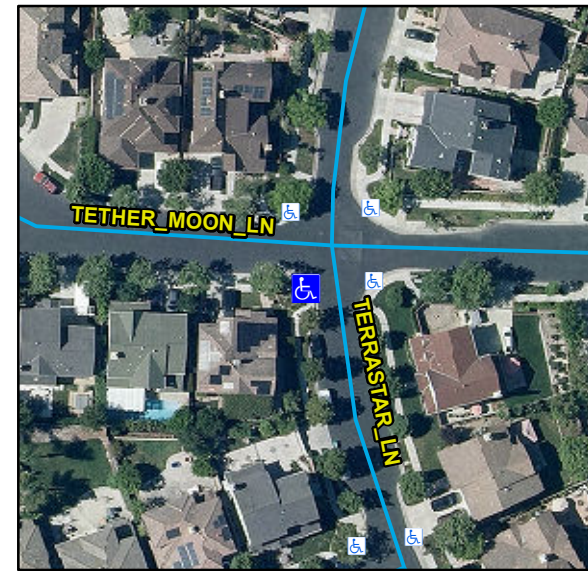
| Compliance | Description | Data | Compliance | Description | Data |
|---|---|---|---|---|---|
| No | Landing Run Slope (%) | 2.2 | Yes | DWS Full Width | Yes |
| No | Gutter Run Slope (%) | 5.9 | | Road Cross Slope (%) | 4.2 |

Remove & Replace Curb Ramp With Two New Directional Ramps or Equivalent. Remove & Replace Gutter.
