# Access Compliance Report Public Rights-of-Way (Curb Ramps)

Main Street: CAPRICORN\_DR Cross Street: TERRASTAR\_LN Location: NW

ADA ID: RPAT211101100505 Ramp Type: Type 4 - Parallel Initial Pass/Fail: Pass Overall Compliance: No Severity Score: 16

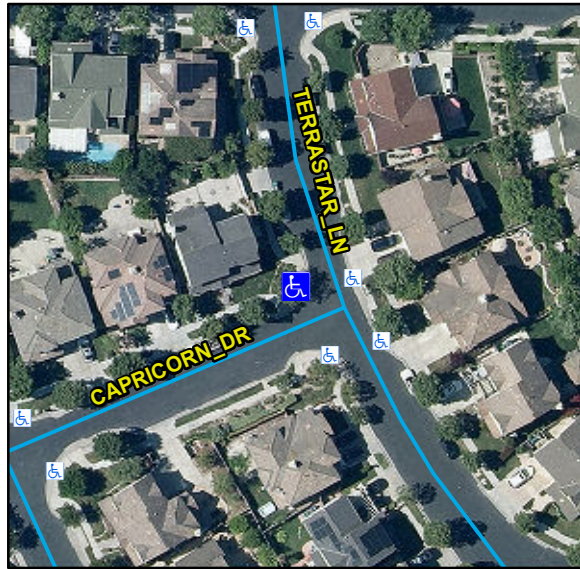
| Compliance | Description | Data | Compliance | Description | Data |
|---|---|---|---|---|---|
| Yes | Ramp Cross Slope LT (%) | 0.5 | No | Ramp Cross Slope RT (%) | 2.8 |
| N/A | Landing Present | Yes | No | DWS Provided | No |
| No | Gutter Run Slope (%) | 5.1 | | Road Cross Slope (%) | 2.4 |
| No | Gutter Cross Slope (%) | 3.8 | No | Perpendicular Joint Present | No |

Remove & Replace Curb Ramp With Two New Directional Ramps or Equivalent. Remove & Replace Gutter.

R204.3, R304.5.3, R305, R304.5.4, STD 1115
