# Access Compliance Report Public Rights-of-Way (Curb Ramps)

Main Street: TERRASTAR\_LN Cross Street: CAPRICORN\_DR Location: SW

ADA ID: RPAT211101100843 Ramp Type: Type 4 - Parallel Initial Pass/Fail: Fail Overall Compliance: No Severity Score: 15

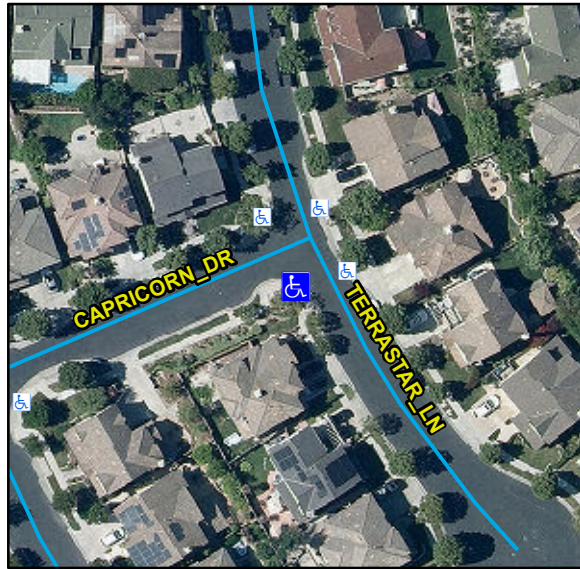
| Compliance | Description | Data | Compliance | Description | Data |
|---|---|---|---|---|---|
| No | Ramp Run Slope LT (%) | 10.7 | Yes | Ramp Run Slope RT (%) | 1.2 |

Remove & Replace Curb Ramp With Two New Directional Ramps or Equivalent.
