# Access Compliance Report Public Rights-of-Way (Curb Ramps)

Main Street: CAPRICORN\_DR Cross Street: GOSSAMER\_PL Location: SE

ADA ID: RPAT211101101159 Ramp Type: Type 4 - Parallel Initial Pass/Fail: Pass Overall Compliance: No Severity Score: 16

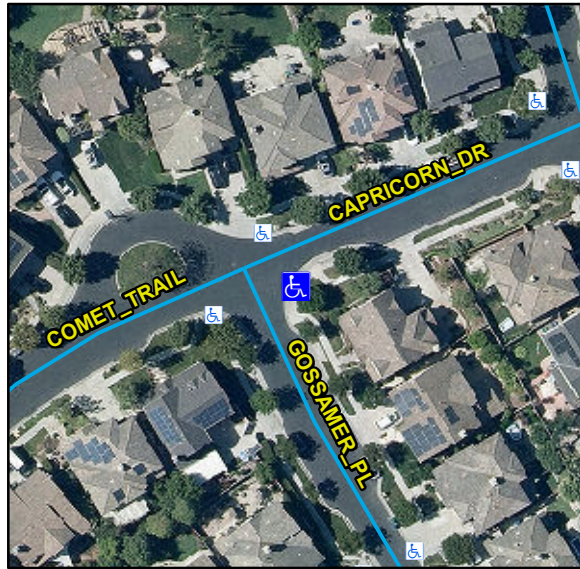
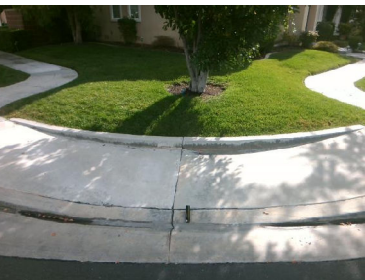
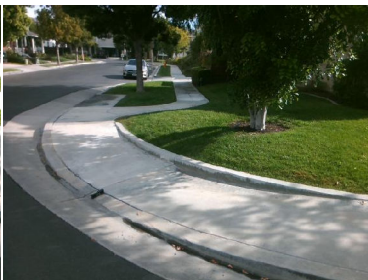
| Compliance | Description | Data | Compliance | Description | Data |
|---|---|---|---|---|---|
| N/A | Landing Present | Yes | No | DWS Provided | No |
| No | Landing Run Slope (%) | 2.4 | N/A | DWS Full Width | N/A |
| Yes | Gutter Ponding | No | No | Curb Slope | 12.3 |
| No | Gutter Run Slope (%) | 12.2 | | Road Cross Slope (%) | 0.8 |

Remove & Replace Curb Ramp With Two New Directional Ramps or Equivalent. Remove & Replace Gutter.

R304.2.2, R204.3, R304.2.2-Perp, R304.3.2-Para, R305, R304.5.4, STD 1115
