# Access Compliance Report Public Rights-of-Way (Curb Ramps)

Main Street: GOSSAMER\_PL Cross Street: COMET\_TRAIL Location: SW

ADA ID: RPAT211101101529 Ramp Type: Type 4 - Parallel Initial Pass/Fail: Fail Overall Compliance: No Severity Score: 2

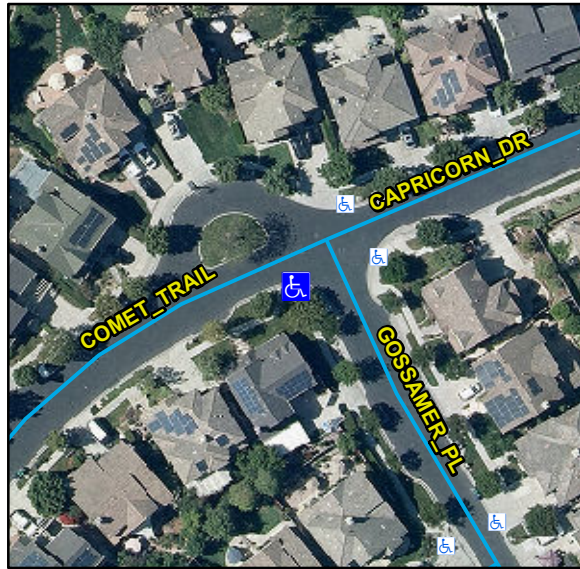
| Compliance | Description | Data | Compliance | Description | Data |
|---|---|---|---|---|---|
| Yes | Ramp Cross Slope LT (%) | 1.9 | No | Ramp Cross Slope RT (%) | 3 |
| N/A | Gutter Cross Slope (%) | N/A | No | Perpendicular Joint Present | No |

Remove & Replace Curb Ramp With Two New Directional Ramps or Equivalent.

R204.3, R304.5.3, STD 1115
