# Access Compliance Report Public Rights-of-Way (Curb Ramps)

Main Street: FLORA\_CT Cross Street: GOSSAMER\_PL Location: NW

ADA ID: RPAT211101101847 Ramp Type: Type 4 - Parallel Initial Pass/Fail: Pass Overall Compliance: No Severity Score: 16

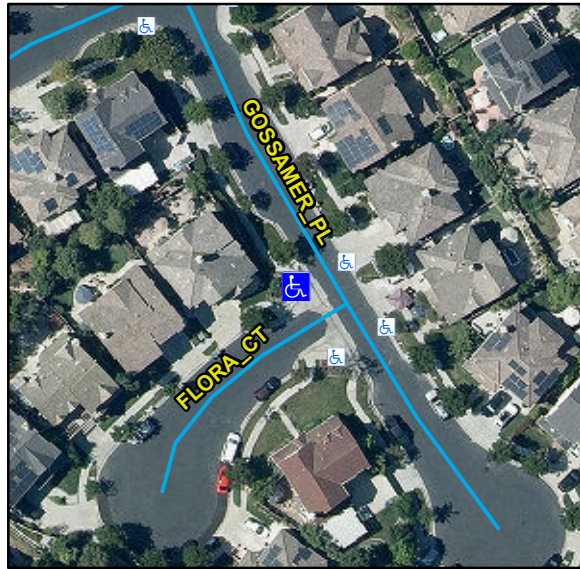
| Compliance | Description | Data | Compliance | Description | Data |
|---|---|---|---|---|---|
| N/A | Landing Present | Yes | No | DWS Provided | No |
| No | Landing Run Slope (%) | 2.5 | N/A | DWS Full Width | N/A |
| No | Gutter Run Slope (%) | 8 | | Road Cross Slope (%) | 2 |

**Remove & Replace Curb Ramp With Two New Directional Ramps or Equivalent. Remove & Replace Gutter.**
