# Access Compliance Report Public Rights-of-Way (Curb Ramps)

Main Street: GOSSAMER\_PL Cross Street: FLORA\_CT Location: SW

ADA ID: RPAT211101102227 Ramp Type: Type 4 - Parallel Initial Pass/Fail: Fail Overall Compliance: No Severity Score: 2

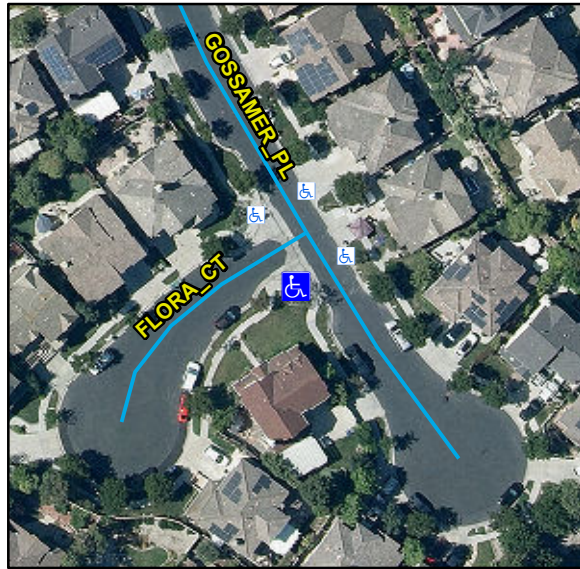
| Compliance | Description | Data | Compliance | Description | Data |
|---|---|---|---|---|---|
| No | Ramp Cross Slope LT (%) | 3.5 | Yes | Ramp Cross Slope RT (%) | 1.9 |

**Remove & Replace Curb Ramp With Two New Directional Ramps or Equivalent.**

**R204.3, R304.5.3, STD 1115**

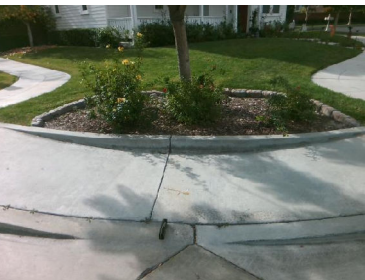
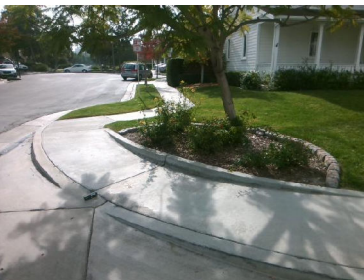
| Compliance | Description | Data | Compliance | Description | Data |
|---|---|---|---|---|---|
| N/A | Gutter Cross Slope (%) | N/A | No | Perpendicular Joint Present | No |
