# Access Compliance Report Public Rights-of-Way (Curb Ramps)

Main Street: COMET\_TRAIL Cross Street: COMET\_TRAIL Location: E

ADA ID: RPAT211101102742 Ramp Type: Type 4 - Parallel Initial Pass/Fail: Fail Overall Compliance: No Severity Score: 16

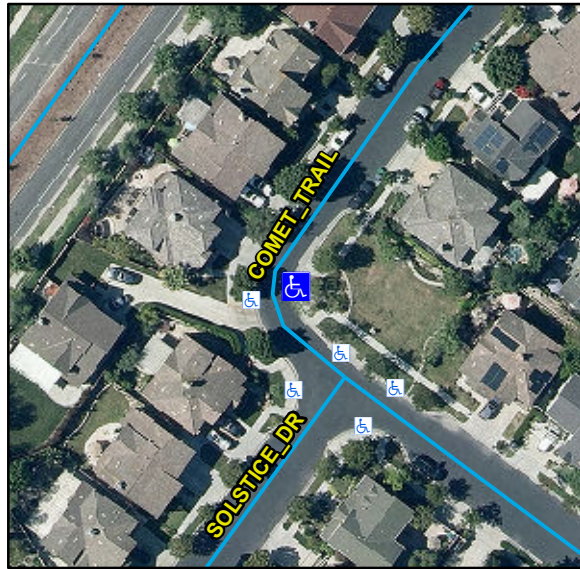
| Compliance | Description | Data | Compliance | Description | Data |
|---|---|---|---|---|---|
| No | Ramp Run Slope LT (%) | 9.2 | Yes | Ramp Run Slope RT (%) | 2.1 |
| No | Ramp Cross Slope LT (%) | 2.7 | No | Ramp Cross Slope RT (%) | 2.3 |

Remove & Replace Entire Ramp.
