# Access Compliance Report Public Rights-of-Way (Curb Ramps)

| Main Street: SOLSTICE_DR | | Cross Street: COMET_TRAIL | | Location: | W |
| ADA ID: RPAT211101103037 | Ramp Type: Type 4 - Parallel | Initial Pass/Fail: Fail | Overall Compliance: No | Severity Score: | 2 |

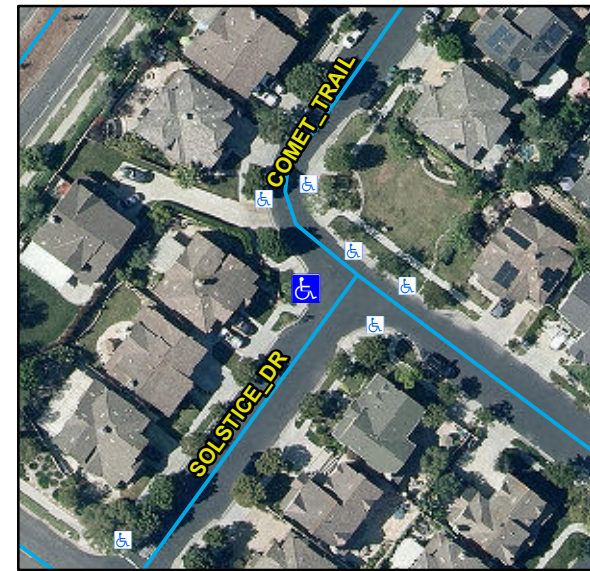
**R304.2.2, R204.3, R304.5.3, STD 1115**

| Compliance | Description | Data | Compliance | Description | Data |
|---|---|---|---|---|---|
| No | Ramp Cross Slope LT (%) | 3.8 | Yes | Ramp Cross Slope RT (%) | 0.6 |
| N/A | Gutter Ponding | N/A | No | Curb Slope | 10.2 |

**Remove & Replace Curb Ramp With Two New Directional Ramps or Equivalent.**

Total Cost: \$ 4000
