# Access Compliance Report Public Rights-of-Way (Curb Ramps)

| Main Street: COMET_TRAIL | | Cross Street: SOLSTICE_DR | | Location: | S |
| ADA ID: RPAT211101103344 | Ramp Type: Type 4 - Parallel | Initial Pass/Fail: Fail | Overall Compliance: No | Severity Score: | 15 |

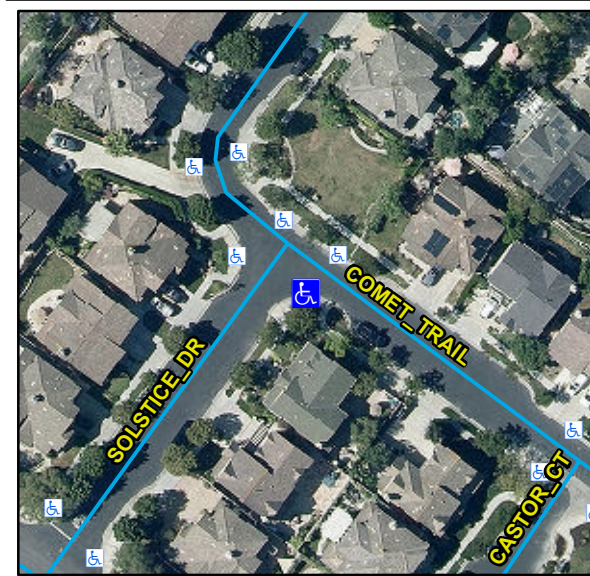
| Compliance | Description | Data | Compliance | Description | Data |
|---|---|---|---|---|---|
| No | Ramp Run Slope LT (%) | 8.4 | Yes | Ramp Run Slope RT (%) | 1.9 |

**Remove & Replace Curb Ramp With Two New Directional Ramps or Equivalent.**

**R204.3, R304.3.2, STD 1115**

Total Cost: \$ 4000
