# Access Compliance Report Public Rights-of-Way (Curb Ramps)

| Main Street: CASTOR_CT | | Cross Street: COMET_TRAIL | | Location: | W |
| ADA ID: RPAT211101103655 | Ramp Type: Type 4 - Parallel | Initial Pass/Fail: Fail | Overall Compliance: No | Severity Score: | 2 |

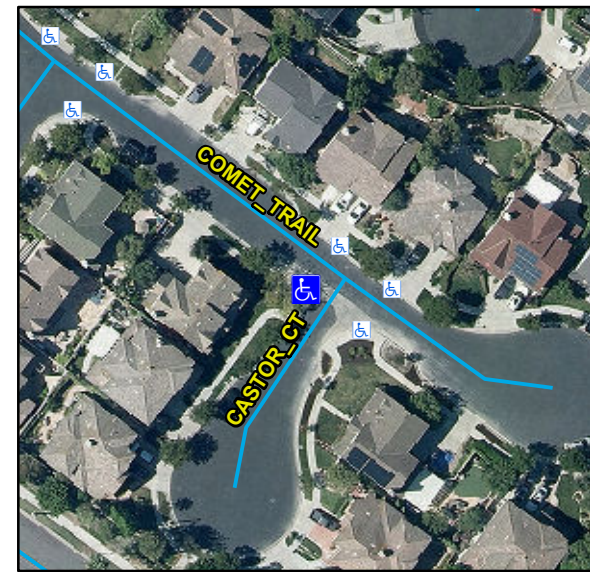
| Compliance | Description | Data | Compliance | Description | Data |
|---|---|---|---|---|---|
| Yes | Ramp Cross Slope LT (%) | 1.6 | No | Ramp Cross Slope RT (%) | 2.2 |
| N/A | Gutter Ponding | N/A | No | Curb Slope | 8.8 |
| N/A | Gutter Cross Slope (%) | N/A | No | Perpendicular Joint Present | No |

Possible Solutions:

**Remove & Replace Curb Ramp With Two New Directional Ramps or Equivalent.**

**R304.2.2, R204.3, R304.5.3, STD 1115**

Total Cost: \$ 4000
