# Access Compliance Report Public Rights-of-Way (Curb Ramps)

Main Street: N\_SELLAS\_RD Cross Street: SOLSTICE\_DR Location: N

ADA ID: RPAT211101104607 Ramp Type: Type 4 - Parallel Initial Pass/Fail: Fail Overall Compliance: No Severity Score: 30

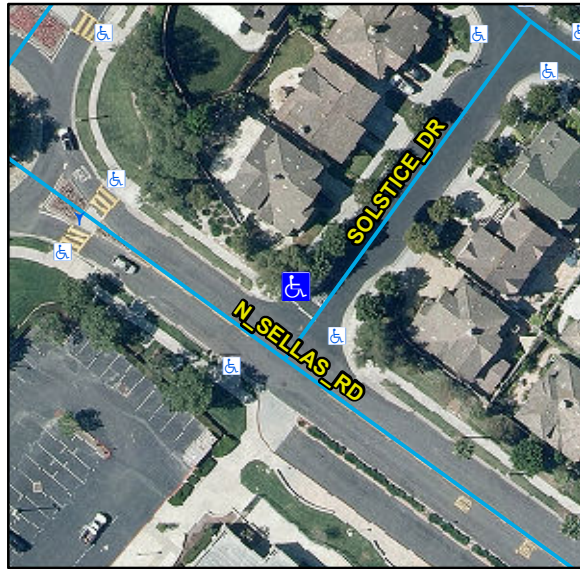
| Compliance | Description | Data | Compliance | Description | Data |
|---|---|---|---|---|---|
| Yes | Ramp Run Slope LT (%) | 3.3 | No | Ramp Run Slope RT (%) | 12.2 |

**Remove & Replace Curb Ramp With Two New Directional Ramps or Equivalent.**

**R204.3, R304.3.2, STD 1115**
