# Access Compliance Report Public Rights-of-Way (Curb Ramps)

Main Street: SOLSTICE\_DR Cross Street: N\_SELLAS\_RD Location: NE

ADA ID: RPAT211101105054 Ramp Type: Type 4 - Parallel Initial Pass/Fail: Fail Overall Compliance: No Severity Score: 2

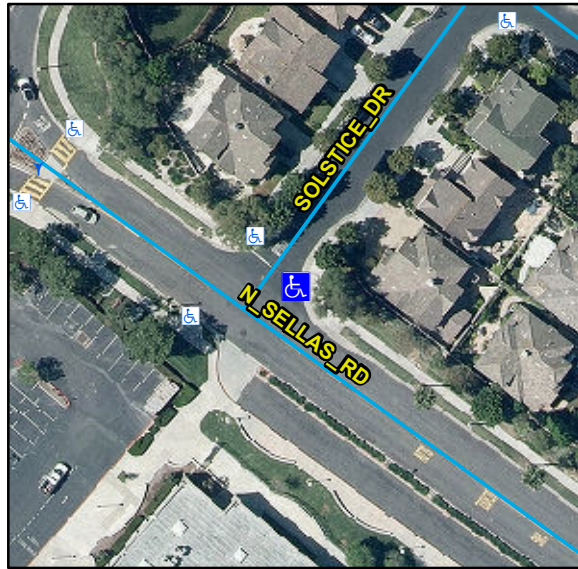
| Compliance | Description | Data | Compliance | Description | Data |
|---|---|---|---|---|---|
| No | Ramp Cross Slope LT (%) | 3.2 | Yes | Ramp Cross Slope RT (%) | 1.7 |
| N/A | Gutter Ponding | N/A | No | Curb Slope | 9.8 |
| N/A | Gutter Cross Slope (%) | N/A | No | Perpendicular Joint Present | No |

**Remove & Replace Curb Ramp With Two New Directional Ramps or Equivalent.**

**R304.2.2, R204.3, R304.5.3, STD 1115**
