# Access Compliance Report Public Rights-of-Way (Curb Ramps)

Main Street: N\_SELLAS\_RD Cross Street: SNAPDRAGON\_ST Location: NW

ADA ID: RPAT211101105442 Ramp Type: Type 4 - Parallel Initial Pass/Fail: Pass Overall Compliance: No Severity Score: 20

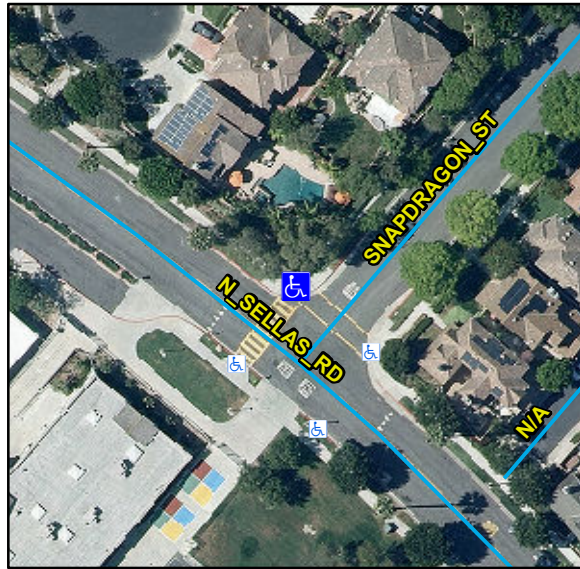
| Compliance | Description | Data | Compliance | Description | Data |
|---|---|---|---|---|---|
| No | Landing Width (in) | 44 | N/A | DWS Length (in) | N/A |
| No | Landing Run Slope (%) | 2.4 | N/A | DWS Full Width | N/A |
| Yes | Gutter Ponding | No | No | Curb Slope | 12.6 |
| No | Gutter Run Slope (%) | 8.1 | | Road Cross Slope (%) | 1.2 |
| Yes | Gutter Cross Slope (%) | 1.2 | No | Perpendicular Joint Present | No |

Remove & Replace Curb Ramp With Two New Directional Ramps or Equivalent. Remove & Replace Gutter.
