# Access Compliance Report Public Rights-of-Way (Curb Ramps)

| Main Street: N_SELLAS_RD | | Cross Street: SNAPDRAGON_ST | | Location: | W |
| ADA ID: RPAT211101105824 | Ramp Type:Type 1 - Perpendicular | Initial Pass/Fail: Pass | Overall Compliance: No | Severity Score: | 15 |

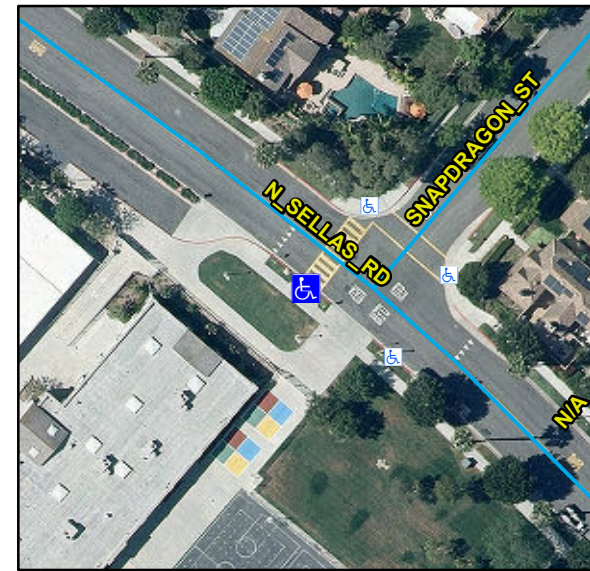
| Compliance | Description | Data | Compliance | Description | Data |
|---|---|---|---|---|---|
| Yes | Landing Cross Slope (%) | 1 | No | DWS Provided | No |
| Yes | Gutter Ponding | No | No | Curb Slope | 8.8 |
| No | Gutter Run Slope (%) | 10.2 | | Road Cross Slope (%) | N/A |

Possible Solutions:

Remove & Replace Entire Ramp. Remove & Replace Gutter.

R304.2.2, R305, R304.5.4, STD 1115
