# Access Compliance Report Public Rights-of-Way (Curb Ramps)

| Main Street: SNAPDRAGON_ST | | Cross Street: N_SELLAS_RD | | Location: | E |
| ADA ID: RPAT211101110225 | Ramp Type: Type 4 - Parallel | Initial Pass/Fail: Fail | Overall Compliance: No | Severity Score: | 15 |

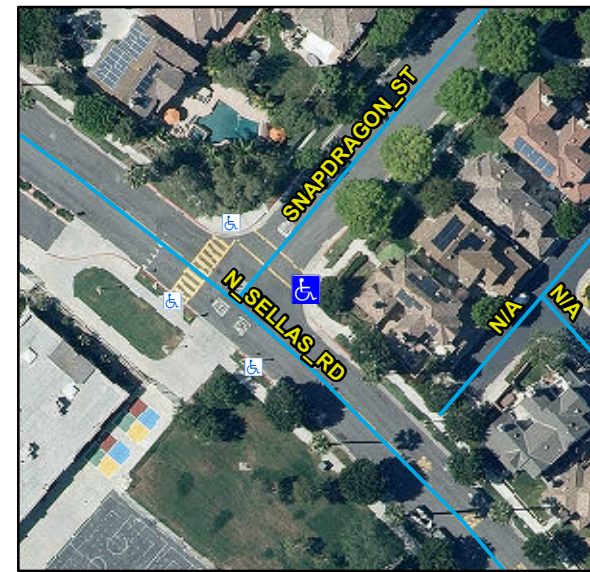
| Compliance | Description | Data | Compliance | Description | Data |
|---|---|---|---|---|---|
| Yes | Ramp Run Slope LT (%) | 0.2 | No | Ramp Run Slope RT (%) | 8.6 |

Possible Solutions:

**Remove & Replace Curb Ramp With Two New Directional Ramps or Equivalent.**

**R204.3, R304.3.2, STD 1115**

Total Cost: \$ 4000
