# Access Compliance Report Public Rights-of-Way (Curb Ramps)

| Main Street: SKLAR_ST | | Cross Street: SNAPDRAGON_ST | | Location: | SW |
| ADA ID: RPAT211101110746 | Ramp Type: Type 4 - Parallel | Initial Pass/Fail: Fail | Overall Compliance: No | Severity Score: | 16 |

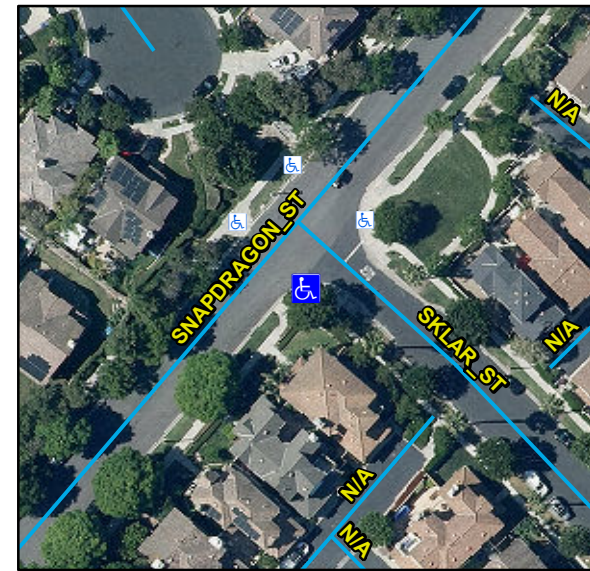
| Compliance | Description | Data | Compliance | Description | Data |
|---|---|---|---|---|---|
| No | Ramp Run Slope LT (%) | 8.8 | Yes | Ramp Run Slope RT (%) | 7 |
| Yes | Ramp Cross Slope LT (%) | 1.1 | No | Ramp Cross Slope RT (%) | 4.3 |

**Remove & Replace Curb Ramp With Two New Directional Ramps or Equivalent.**

**R204.3, R304.3.2, R304.5.3, STD 1115**

Total Cost: \$ 4000

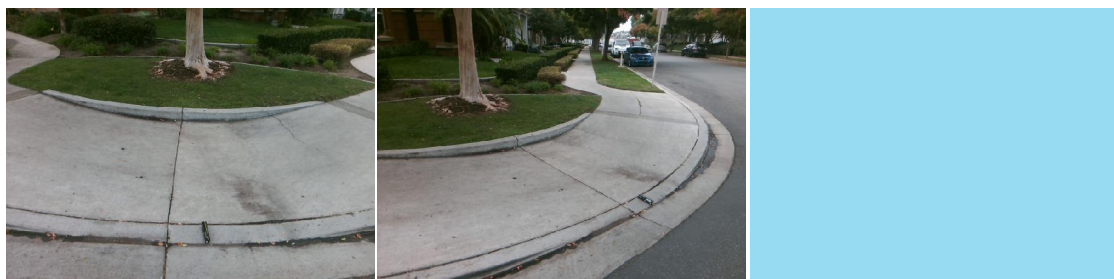
| Compliance | Description | Data | Compliance | Description | Data |
|---|---|---|---|---|---|
| N/A | Ramp Length LT (in) | 96 | N/A | Ramp Length RT (in) | 95 |
| Yes | Ramp Width LT (in) | 88 | Yes | Ramp Width RT (in) | 88 |
