# Access Compliance Report Public Rights-of-Way (Curb Ramps)

| Main Street: SNAPDRAGON_ST | | Cross Street: SKLAR_ST | | Location: | NW |
| ADA ID: RPAT211101111131 | Ramp Type:Type 1 - Perpendicular | Initial Pass/Fail: Fail | Overall Compliance: No | Severity Score: | 16 |

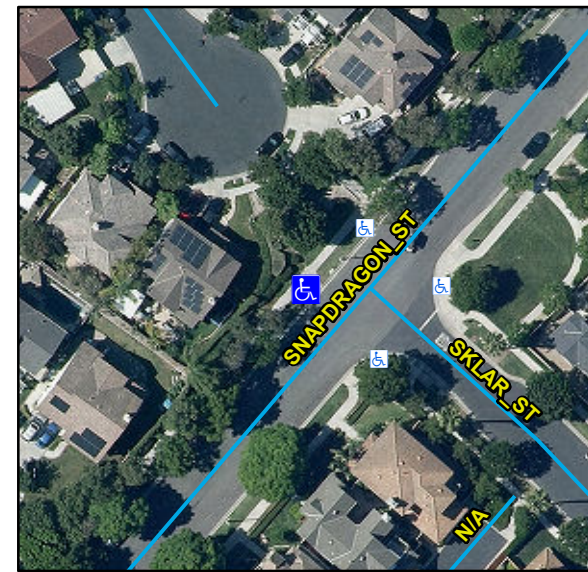
| Compliance | Description | Data | Compliance | Description | Data |
|---|---|---|---|---|---|
| No | Ramp Run Slope (%) | 8.7 | N/A | Flare Slope LT (%) | N/A |

Remove & Replace Entire Ramp.

R204.3, R304.2.2, STD 1115
