# Access Compliance Report Public Rights-of-Way (Curb Ramps)

Main Street: SNAPDRAGON\_ST Cross Street: SKLAR\_ST Location: SE

ADA ID: RPAT211101111408 Ramp Type: Type 4 - Parallel Initial Pass/Fail: Pass Overall Compliance: No Severity Score: 14

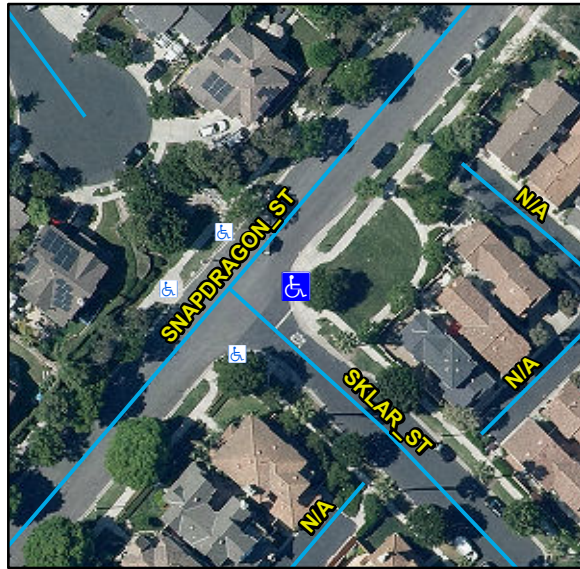
| Compliance | Description | Data | Compliance | Description | Data |
|---|---|---|---|---|---|
| N/A | Landing Present | Yes | No | DWS Provided | No |
| No | Landing Width (in) | 47 | N/A | DWS Length (in) | N/A |
| Yes | Gutter Ponding | No | No | Curb Slope | 18 |
| No | Gutter Cross Slope (%) | 2.5 | No | Perpendicular Joint Present | No |

Remove & Replace Curb Ramp With Two New Directional Ramps or Equivalent. Remove & Replace Gutter.

R304.2.2, R204.3, R304.2.1, R305, R304.5.3, STD 1115
