# Access Compliance Report Public Rights-of-Way (Curb Ramps)

Main Street: BELLFLOWER\_ST Cross Street: TETHER\_MOON\_LN Location: SW

ADA ID: RPAT211101124530 Ramp Type: Type 4 - Parallel Initial Pass/Fail: Fail Overall Compliance: No Severity Score: 2

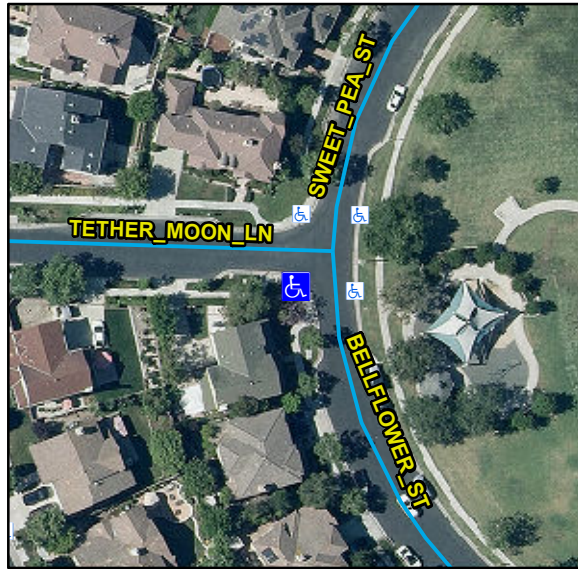
| Compliance | Description | Data | Compliance | Description | Data |
|---|---|---|---|---|---|
| No | Ramp Cross Slope LT (%) | 2.1 | Yes | Ramp Cross Slope RT (%) | 1.8 |

Remove & Replace Curb Ramp With Two New Directional Ramps or Equivalent.

R204.3, R304.5.3, STD 1115
