# Access Compliance Report Public Rights-of-Way (Curb Ramps)

| Main Street: TETHER_MOON_LN | | Cross Street: SWEET_PEA_ST | | Location: | NW |
| ADA ID: RPAT211101125019 | Ramp Type: Type 4 - Parallel | Initial Pass/Fail: Pass | Overall Compliance: No | Severity Score: | 5 |

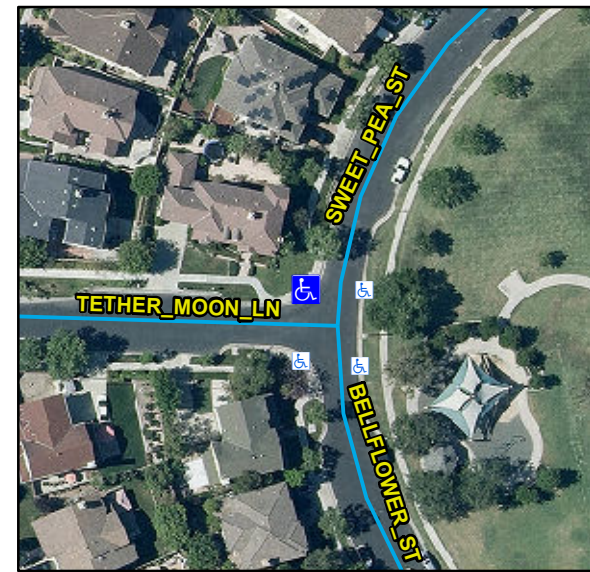
| Compliance | Description | Data | Compliance | Description | Data |
|---|---|---|---|---|---|
| No | Landing Cross Slope (%) | 4.8 | | DWS Offset Type | Single |
| Yes | Gutter Ponding | No | No | Curb Slope | 8.9 |
| No | Gutter Run Slope (%) | 7 | | Road Cross Slope (%) | 2.8 |
| No | Gutter Cross Slope (%) | 3.3 | No | Perpendicular Joint Present | No |

**Remove & Replace Curb Ramp With Two New Directional Ramps or Equivalent. Remove & Replace Gutter.**

**R304.2.2, R204.3, R304.5.3, R304.5.4, STD 1115**

Total Cost: \$ 4252

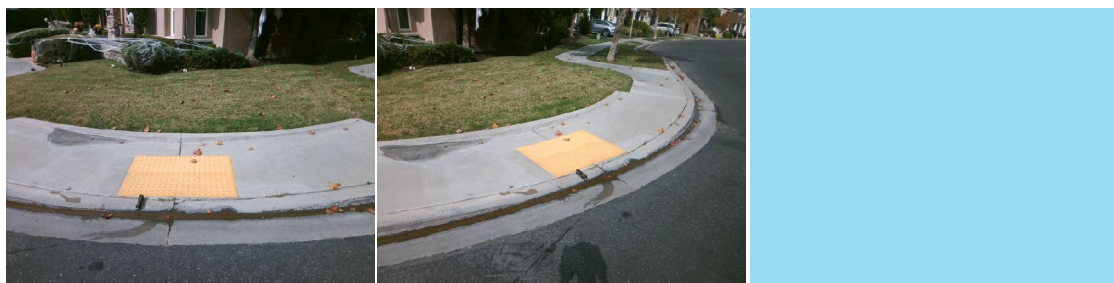
| Compliance | Description | Data | Compliance | Description | Data |
|---|---|---|---|---|---|
| N/A | Ramp Length LT (in) | 110 | N/A | Ramp Length RT (in) | 99 |
| Yes | Ramp Width LT (in) | 53 | Yes | Ramp Width RT (in) | 54 |
| Yes | Ramp Run Slope LT (%) | 2.1 | Yes | Ramp Run Slope RT (%) | 8.3 |
| Yes | Ramp Cross Slope LT (%) | 0.2 | Yes | Ramp Cross Slope RT (%) | 1 |
