# Access Compliance Report Public Rights-of-Way (Curb Ramps)

| Main Street: SWEET_PEA_ST | | Cross Street: SNAPDRAGON_ST | | Location: | NW |
| ADA ID: RPAT211101125748 | Ramp Type: Type 4 - Parallel | Initial Pass/Fail: Fail | Overall Compliance: No | Severity Score: | 32 |

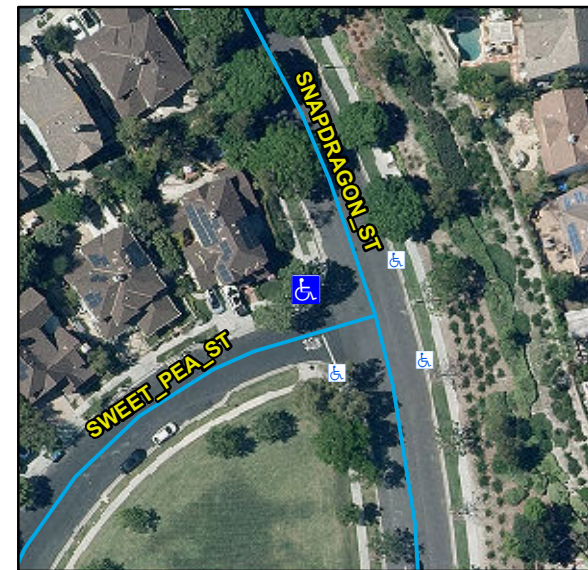
| Compliance | Description | Data | Compliance | Description | Data |
|---|---|---|---|---|---|
| Yes | Ramp Run Slope LT (%) | 1.1 | No | Ramp Run Slope RT (%) | 12.1 |
| Yes | Ramp Cross Slope LT (%) | 1.5 | No | Ramp Cross Slope RT (%) | 2.5 |

**Remove & Replace Curb Ramp With Two New Directional Ramps or Equivalent.**

**R204.3, R304.3.2, R304.5.3, STD 1115**

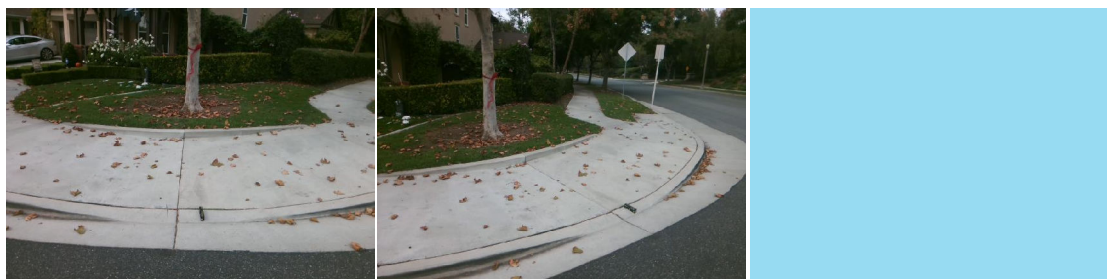
| Compliance | Description | Data | Compliance | Description | Data |
|---|---|---|---|---|---|
| N/A | Ramp Length LT (in) | 95 | N/A | Ramp Length RT (in) | 82 |
| Yes | Ramp Width LT (in) | 90 | Yes | Ramp Width RT (in) | 89 |
