# Access Compliance Report Public Rights-of-Way (Curb Ramps)

Main Street: SNAPDRAGON\_ST Cross Street: SWEET\_PEA\_ST Location: SW

ADA ID: RPAT211101130354 Ramp Type: Type 1 - Perpendicular Diagonal Initial Pass/Fail: Pass Overall Compliance: No Severity Score: 25

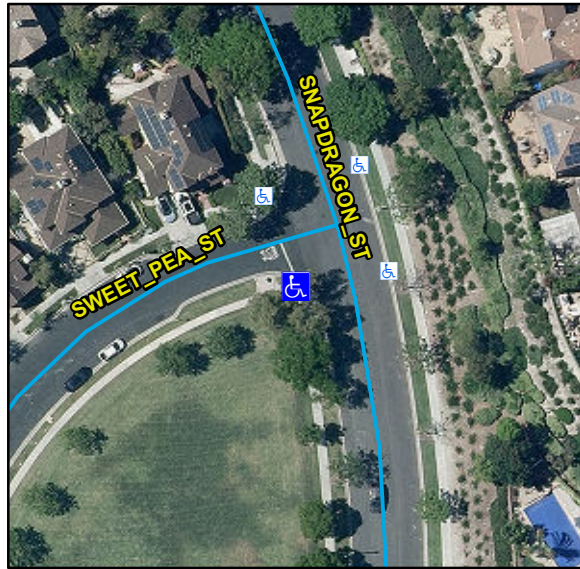
| Compliance | Description | Data | Compliance | Description | Data |
|---|---|---|---|---|---|
| No | Landing Width (in) | N/A | N/A | Flare Slope RT (%) | 3.7 |
| No | Landing Run Slope (%) | N/A | N/A | Flare Traversable RT | No |
| No | Landing Cross Slope (%) | N/A | No | DWS Provided | No |
| Yes | Gutter Ponding | No | No | Curb Slope | 11.5 |
| No | Gutter Run Slope (%) | 8.2 | | Road Cross Slope (%) | 4.1 |

Remove & Replace Curb Ramp With Two New Directional Ramps or Equivalent. Remove & Replace Gutter.
