# Access Compliance Report Public Rights-of-Way (Curb Ramps)

| Main Street: BELLFLOWER_ST | | Cross Street: SNAPDRAGON_ST | | Location: | NW |
| ADA ID: RPAT211101131115 | Ramp Type: Type 4 - Parallel | Initial Pass/Fail: Fail | Overall Compliance: No | Severity Score: | 2 |

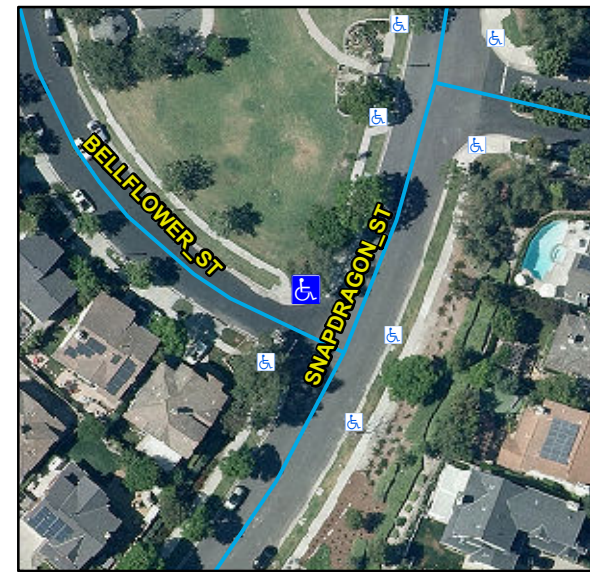
| Compliance | Description | Data | Compliance | Description | Data |
|---|---|---|---|---|---|
| No | Ramp Cross Slope LT (%) | 2.3 | Yes | Ramp Cross Slope RT (%) | 0.8 |
| N/A | Gutter Ponding | N/A | No | Curb Slope | 9.2 |

Possible Solutions:

**Remove & Replace Curb Ramp With Two New Directional Ramps or Equivalent.**

**R304.2.2, R204.3, R304.5.3, STD 1115**

Total Cost: \$ 4000
