# Access Compliance Report Public Rights-of-Way (Curb Ramps)

Main Street: SNAPDRAGON\_ST Cross Street: BELLFLOWER\_ST Location: W

ADA ID: RPAT211101131722 Ramp Type: Type 1 - Perpendicular Diagonal Initial Pass/Fail: Fail Overall Compliance: No Severity Score: 2

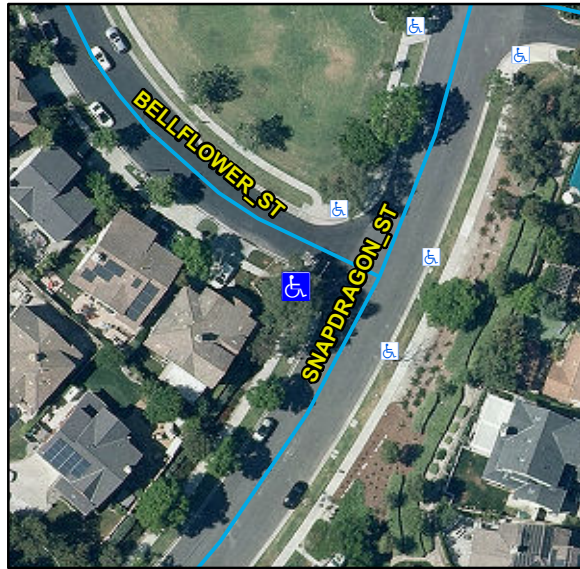
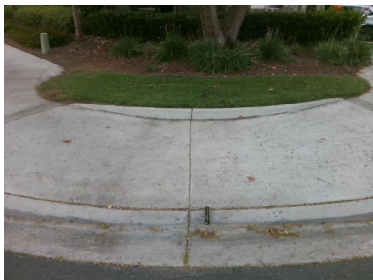
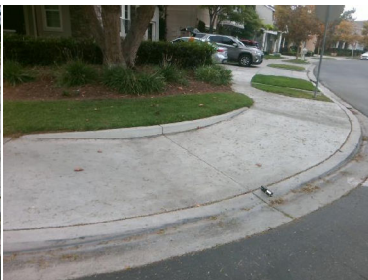
R304.2.2, R204.3, R304.5.3, STD 1115

| Compliance | Description | Data | Compliance | Description | Data |
|---|---|---|---|---|---|
| No | Ramp Cross Slope (%) | 2.4 | N/A | Flare Traversable LT | N/A |

Remove & Replace Curb Ramp With Two New Directional Ramps or Equivalent.
