# Access Compliance Report Public Rights-of-Way (Curb Ramps)

Main Street: SHELTON\_CT Cross Street: STERLING\_GLEN Location: NE

ADA ID: RPAT211101135327 Ramp Type: Type 4 - Parallel Initial Pass/Fail: Fail Overall Compliance: No Severity Score: 32

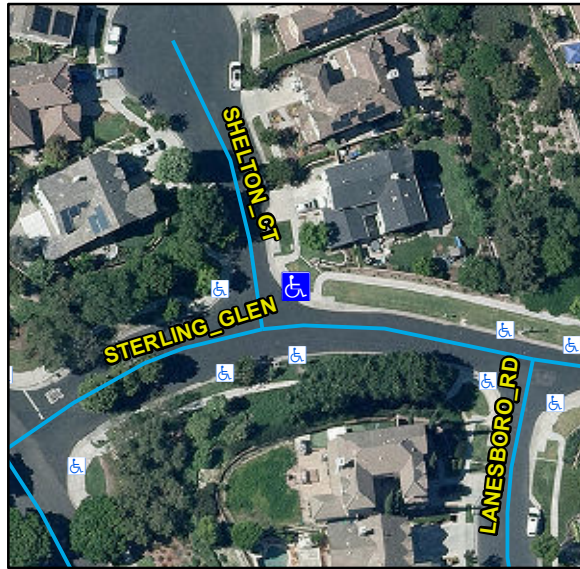
| Compliance | Description | Data | Compliance | Description | Data |
|---|---|---|---|---|---|
| Yes | Ramp Run Slope LT (%) | 3.4 | No | Ramp Run Slope RT (%) | 12.7 |
| No | Ramp Cross Slope LT (%) | 2.9 | Yes | Ramp Cross Slope RT (%) | 1.8 |

Remove & Replace Curb Ramp With Two New Directional Ramps or Equivalent.
