# Access Compliance Report Public Rights-of-Way (Curb Ramps)

Main Street: STERLING\_GLEN Cross Street: SHELTON\_CT Location: NW

ADA ID: RPAT211101135638 Ramp Type: Type 4 - Parallel Initial Pass/Fail: Fail Overall Compliance: No Severity Score: 32

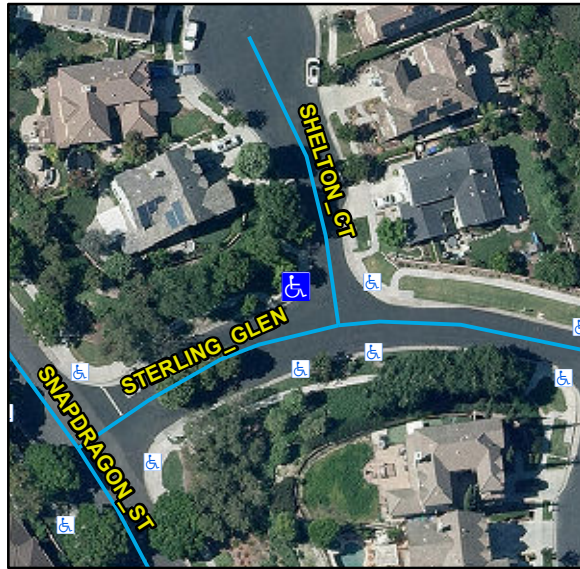
| Compliance | Description | Data | Compliance | Description | Data |
|---|---|---|---|---|---|
| Yes | Ramp Run Slope LT (%) | 5.4 | No | Ramp Run Slope RT (%) | 12.9 |
| No | Ramp Cross Slope LT (%) | 3.1 | No | Ramp Cross Slope RT (%) | 2.5 |

Remove & Replace Curb Ramp With Two New Directional Ramps or Equivalent.

R204.3, R304.5.3, R304.3.2, STD 1115
