# Access Compliance Report Public Rights-of-Way (Curb Ramps)

Main Street: SNAPDRAGON\_ST Cross Street: STERLING\_GLEN Location: SW

ADA ID: RPAT211101140627 Ramp Type: Type 1 - Perpendicular Initial Pass/Fail: Fail Overall Compliance: No Severity Score: 2

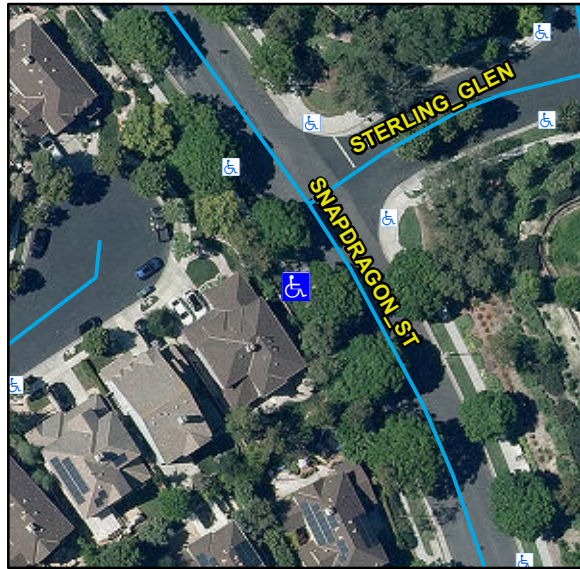
| Compliance | Description | Data | Compliance | Description | Data |
|---|---|---|---|---|---|
| No | Ramp Cross Slope (%) | 3.6 | N/A | Flare Traversable LT | N/A |

Remove & Replace Entire Ramp.

R304.2.2, R304.5.3, STD 1115
