# Access Compliance Report Public Rights-of-Way (Curb Ramps)

Main Street: BLUE\_SPRUCE\_DR Cross Street: SCOTCH\_PINE\_DR Location: NW

ADA ID: RPAT211101142940 Ramp Type: Type 4 - Parallel Initial Pass/Fail: Fail Overall Compliance: No Severity Score: 32

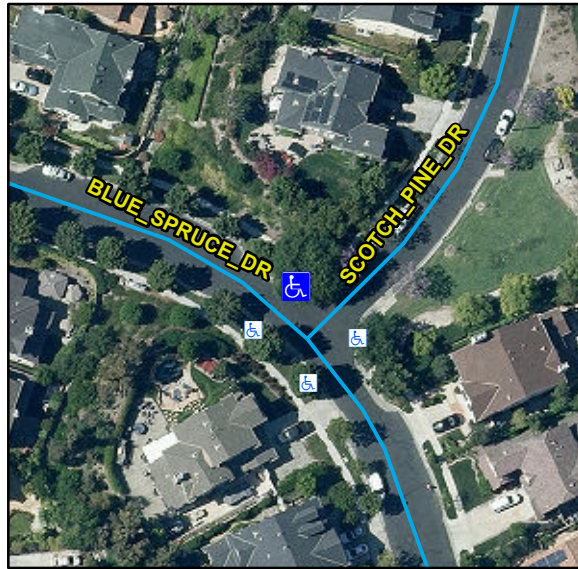
| Compliance | Description | Data | Compliance | Description | Data |
|---|---|---|---|---|---|
| Yes | Ramp Run Slope LT (%) | 1.1 | No | Ramp Run Slope RT (%) | 14.8 |
| Yes | Ramp Cross Slope LT (%) | 1.9 | No | Ramp Cross Slope RT (%) | 2.7 |

Remove & Replace Curb Ramp With Two New Directional Ramps or Equivalent.

R204.3, R304.3.2, R304.5.3, STD 1115
