# Access Compliance Report Public Rights-of-Way (Curb Ramps)

| Main Street: SCOTCH_PINE_DR | | Cross Street: BLUE_SPRUCE_DR | | Location: | E |
| ADA ID: RPAT211101143234 | Ramp Type: Type 4 - Parallel | Initial Pass/Fail: Fail | Overall Compliance: No | Severity Score: | 16 |

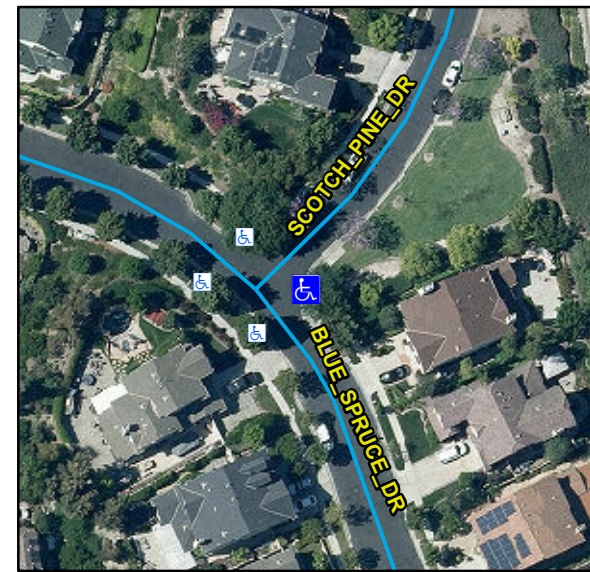
| Compliance | Description | Data | Compliance | Description | Data |
|---|---|---|---|---|---|
| Yes | Ramp Run Slope LT (%) | 3.6 | No | Ramp Run Slope RT (%) | 10.3 |
| Yes | Ramp Cross Slope LT (%) | 1.2 | No | Ramp Cross Slope RT (%) | 2.2 |

**Remove & Replace Curb Ramp With Two New Directional Ramps or Equivalent.**

**R204.3, R304.3.2, R304.5.3, STD 1115**

Total Cost: \$ 4000

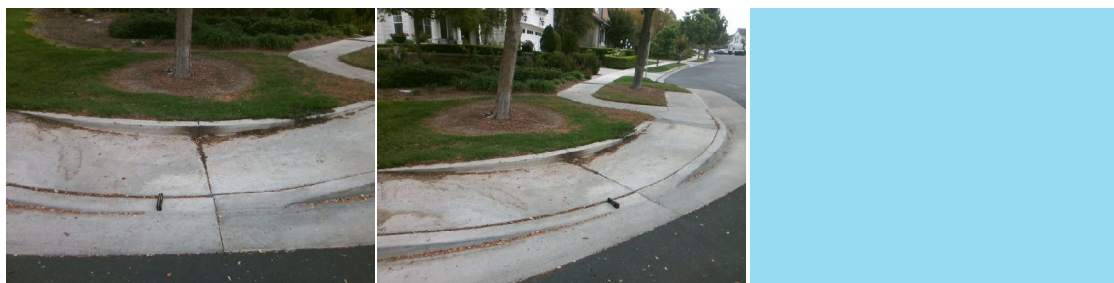
| Compliance | Description | Data | Compliance | Description | Data |
|---|---|---|---|---|---|
| N/A | Ramp Length LT (in) | 100 | N/A | Ramp Length RT (in) | 105 |
| Yes | Ramp Width LT (in) | 54 | Yes | Ramp Width RT (in) | 52 |
