# Access Compliance Report Public Rights-of-Way (Curb Ramps)

| Main Street: MAGNOLIA_DR | | Cross Street: BLUE_SPRUCE_DR | | Location: | E |
| ADA ID: RPAT211101143831 | Ramp Type: Type 4 - Parallel | Initial Pass/Fail: Fail | Overall Compliance: No | Severity Score: | 32 |

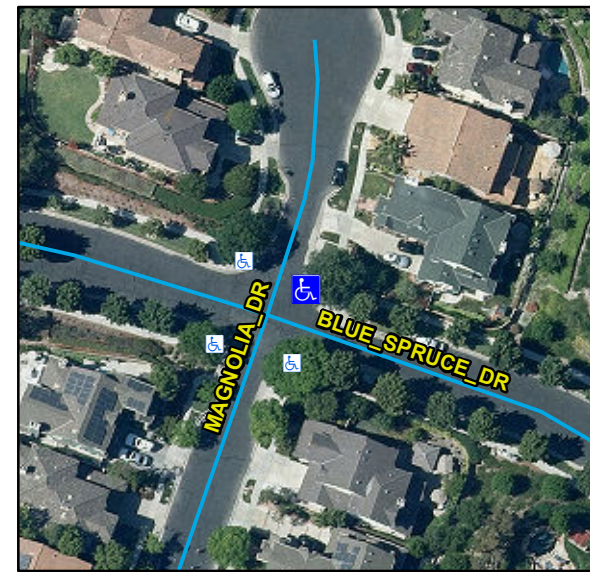
| Compliance | Description | Data | Compliance | Description | Data |
|---|---|---|---|---|---|
| Yes | Ramp Run Slope LT (%) | 2.7 | No | Ramp Run Slope RT (%) | 12.5 |
| No | Ramp Cross Slope LT (%) | 3.9 | No | Ramp Cross Slope RT (%) | 4 |

**Remove & Replace Curb Ramp With Two New Directional Ramps or Equivalent.**

**R204.3, R304.5.3, R304.3.2, STD 1115**

Total Cost: \$ 4000

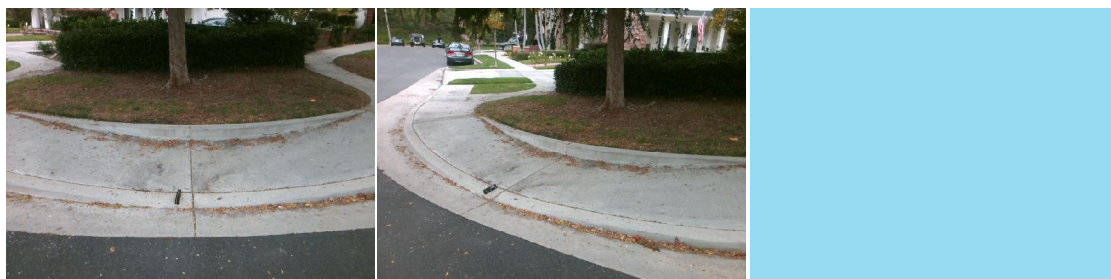
| Compliance | Description | Data | Compliance | Description | Data |
|---|---|---|---|---|---|
| N/A | Ramp Length LT (in) | 115 | N/A | Ramp Length RT (in) | 110 |
| Yes | Ramp Width LT (in) | 54 | Yes | Ramp Width RT (in) | 54 |
