# Access Compliance Report Public Rights-of-Way (Curb Ramps)

Main Street: BLUE\_SPRUCE\_DR Cross Street: MAGNOLIA\_DR Location: N

ADA ID: RPAT211101144051 Ramp Type: Type 4 - Parallel Initial Pass/Fail: Fail Overall Compliance: No Severity Score: 32

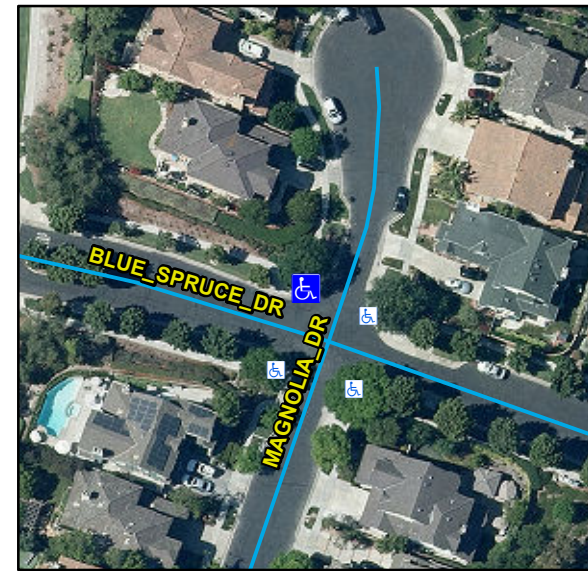
| Compliance | Description | Data | Compliance | Description | Data |
|---|---|---|---|---|---|
| Yes | Ramp Run Slope LT (%) | 1.6 | No | Ramp Run Slope RT (%) | 14.6 |
| No | Ramp Cross Slope LT (%) | 3.3 | No | Ramp Cross Slope RT (%) | 2.1 |

**Remove & Replace Curb Ramp With Two New Directional Ramps or Equivalent.**

**R204.3, R304.5.3, R304.3.2, STD 1115**
