# Access Compliance Report Public Rights-of-Way (Curb Ramps)

| Main Street: MAGNOLIA_DR | | Cross Street: BLUE_SPRUCE_DR | | Location: | W |
| ADA ID: RPAT211101144356 | Ramp Type: Type 4 - Parallel | Initial Pass/Fail: Fail | Overall Compliance: No | Severity Score: | 30 |

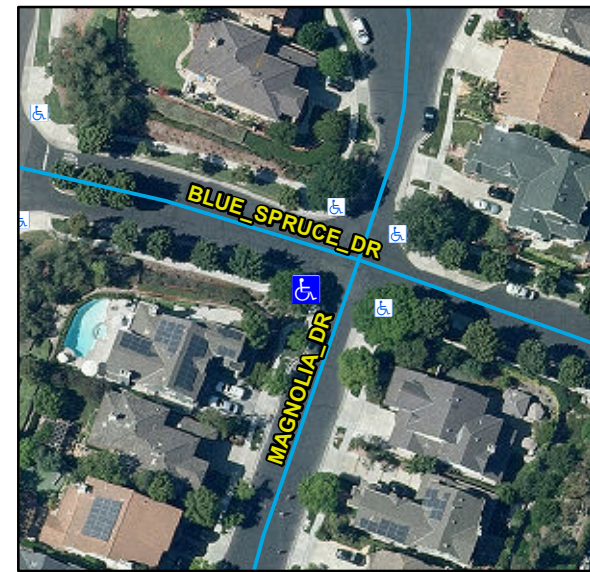
| Compliance | Description | Data | Compliance | Description | Data |
|---|---|---|---|---|---|
| No | Ramp Run Slope LT (%) | 13 | Yes | Ramp Run Slope RT (%) | 2.1 |

**Remove & Replace Curb Ramp With Two New Directional Ramps or Equivalent.**

**R204.3, R304.3.2, STD 1115**

Total Cost: \$ 4000

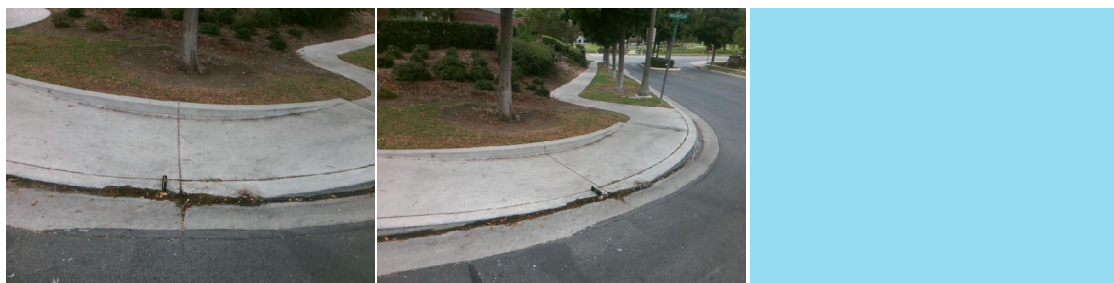
| Compliance | Description | Data | Compliance | Description | Data |
|---|---|---|---|---|---|
| N/A | Ramp Length LT (in) | 115 | N/A | Ramp Length RT (in) | 110 |
| Yes | Ramp Width LT (in) | 53 | Yes | Ramp Width RT (in) | 53 |
| Yes | Ramp Cross Slope LT (%) | 1 | Yes | Ramp Cross Slope RT (%) | 1.2 |
