# Access Compliance Report Public Rights-of-Way (Curb Ramps)

| Main Street: BLUE_SPRUCE_DR | | Cross Street: MAGNOLIA_DR | | Location: | S |
| ADA ID: RPAT211101144717 | Ramp Type: Type 4 - Parallel | Initial Pass/Fail: Fail | Overall Compliance: No | Severity Score: | 15 |

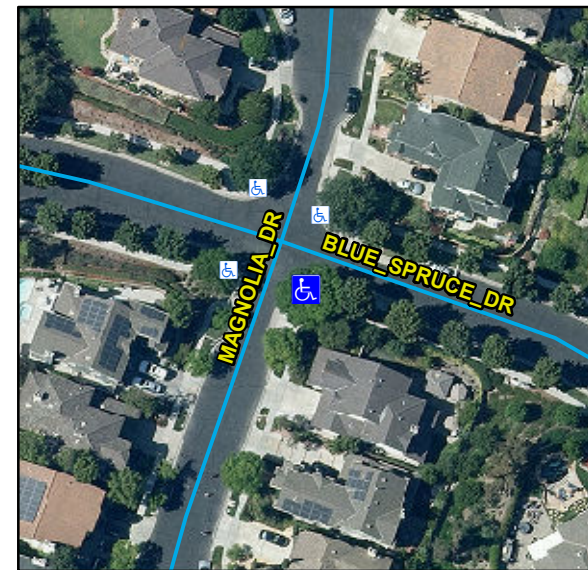
| Compliance | Description | Data | Compliance | Description | Data |
|---|---|---|---|---|---|
| No | Ramp Run Slope LT (%) | 11.7 | Yes | Ramp Run Slope RT (%) | 0.6 |

Possible Solutions:

**Remove & Replace Curb Ramp With Two New Directional Ramps or Equivalent.**

**R204.3, R304.3.2, STD 1115**

Total Cost: \$ 4000
